## STAR ONLINE PUBLICATION

**Case Number:** S2323000045

**Symptom/Vehicle Issue:** Stamping Mark On Under Hood Reinforcement.

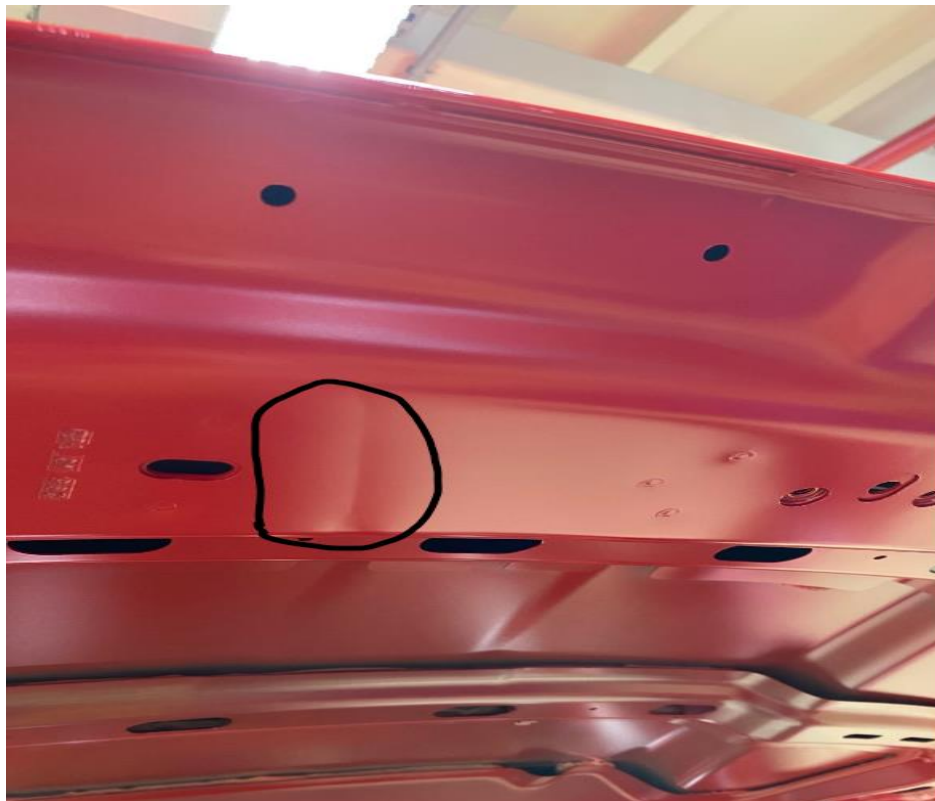
**Customer Complaint/Technician Observation:** The customer or technician may observe that a mark is present on the underside of the hood assembly to the left of the hood striker (facing the vehicle).

**Discussion:** The mark, if like the figure below, is found it is normal and does not affect operation. The hood should not be replaced, or metal finished for this mark.
