STAR ONLINE PUBLICATION

Case Number: S2308000066 Rev. B

Symptom/Vehicle Issue: Dome Lamp, Ultrasonic Antitilt Module (UAM), Alarm Siren Unit (ASU) Inoperative After a Recent Module Flash

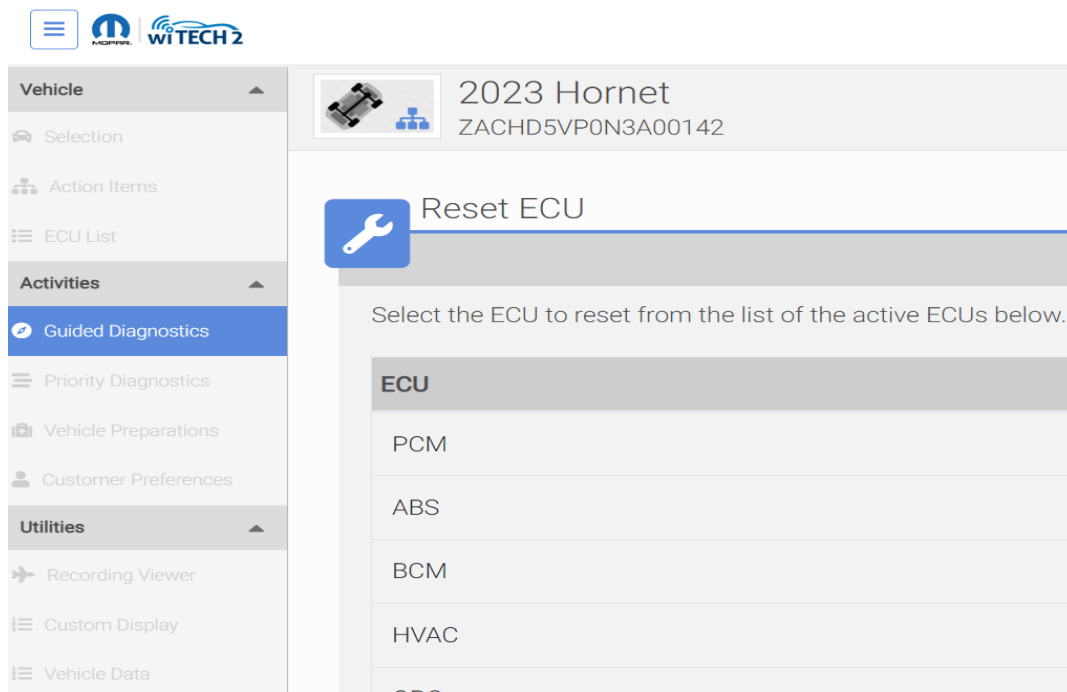
Technician Observation: Dome lamps do not turn on as expected, security warning lamp on, or Diagnostic Trouble Codes (DTC's) U1413-09, U1413-87 for UAM or U1412-09 for ASU.

Discussion: If the dome lamps do not operate after a recent service repair/module flash or the vehicle has the above DTCs. Use the scan tool to perform a Body Control Module (BCM) reset. Use the **wiTech select > Guided Diagnostics > Reset ECU > BCM**. Check the operation, if the dome lamps are still inoperative, perform a momentary battery disconnect and without delay reconnect the battery. No parts required, test the operation to complete.
