STAR ONLINE PUBLICATION

Case Number: S2308000036 Rev. C

Symptom/Vehicle Issue: Cluster Displays an Electric Power Steering (EPS) Fault Warning Lamp or Service Power Steering Message

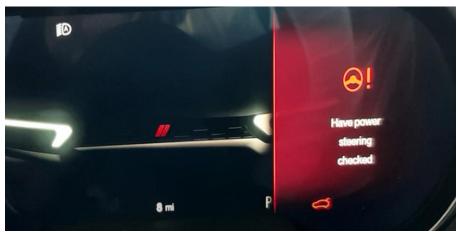
Technician Observation: After an EPS replacement and or EPS control module service the EPS cluster warning lamp remains on. The cluster may display "Have Power Steering Checked" message with a steering wheel icon displayed on the instrument cluster.

Discussion: Perform the **Lock-to-Lock** steering angle calibration. This procedure is for steering rack center position learning.

Perform Calibration: – Start the vehicle and adjust the tires so they are in the straightforward position. Calibration is performed by turning the steering wheel lock to lock with a slight applied steering torque while in the full steering wheel locked positions and holding the full locked position for a minimum of 5 seconds.

Start the vehicle, with the steering wheel centered tires in the straight ahead position, turn the steering wheel to a full lock position to the right or left. Hold the steering wheel for a minimum of 5 seconds with slight torque applied (min torque 6Nm) while at the stop position. Then rotate the steering wheel to the full lock position in the opposite direction, again holding the steering wheel against the stop for a minimum of 5 seconds (min torque of 6Nm). Return the steering wheel/tires to the centered straight ahead position, turn the vehicle off and wait for all the lights to turn off, then turn the key back on to complete.
