## STAR ONLINE PUBLICATION

Case Number: S2323000049

**Symptom/Vehicle Issue:** Buzz Squeak Rattle (BSR) Noise From Under Vehicle While Operating Or Driving.

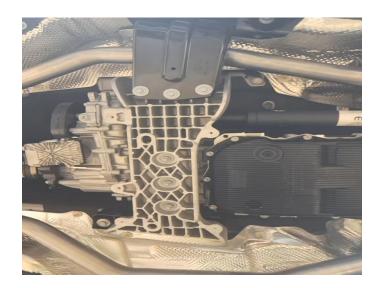
**Customer Complaint/Technician Observation:** Customer may complain of a BSR while driving. Complaint may be specific to rough or bumpy roads. The noise could even be described as a clunk or thud.

**Discussion**: Inspect all under chassis fasteners such as transmission crossmember, heat shields, and brackets for proper installation and fastener torque. Move or ensure any shields and brackets have clearance and are not contacting other components making noises. Replace any components as necessary.
