STAR ONLINE PUBLICATION

Case Number: S238A000031

Symptom/Vehicle Issue: Uconnect Box Require Service Message

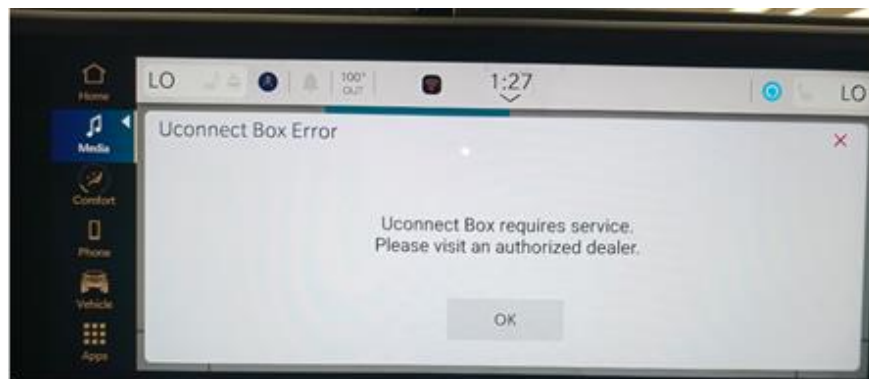
Fig 1

Customer Complaint/Technician Observation: Customer/ technician may receive a message of "Uconnect box requires service. Please visit an authorized dealer" on the radio screen. It may happen right after the vehicle switching to customer mode. This will appear at every key cycle.

An issue with the software loaded in the offboard server has been identified that causes this message to appear. This is expected to be corrected by 6-30-23. Please verify that there are no Diagnostic Trouble Codes (DTCs) for TBM. These DTCs may also cause this message appears and should be addressed. If no DTCs are present, please wait for the offboard server issue to be resolved. This will be done on the backend and no interaction from dealer is needed.

Do not replace TBM for this concern.
