STAR ONLINE PUBLICATION

Case Number: S2324000010

Symptom/Vehicle Issue: Customer Indicates Low Air Flow Out Of Dash Vent.

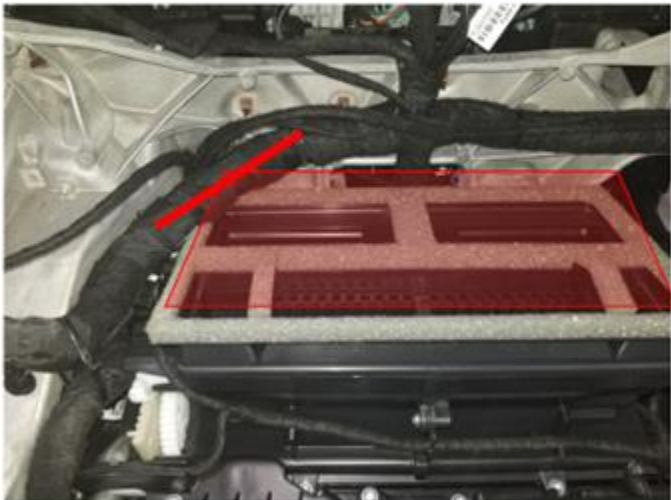
Customer Complaint/Technician Observation: After further investigation the tech may see that the cross-car duct is partially crushed during install by a misrouted dash harness.

Harness Interfering With Opening

Discussion: Pull the duct and inspect for the corner to be pushed in by the harness (shown below). If it is found damaged, the duct will require replacement. Remove the damaged duct, route the harness back away from the duct to prevent contact when installing, install new duct and retest operation.

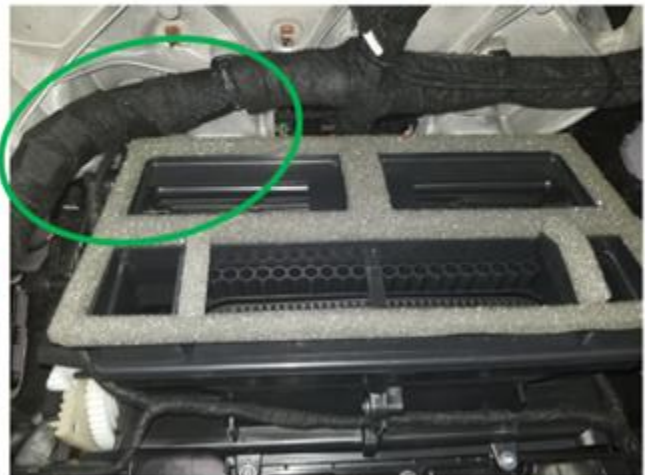
Harness Not Interfering With Opening
