REFERENCE:	TSB: 23-062-23 GROUP 23 - Body	Date:	June 3, 2023	REVISION:	-
VEHICLES AFFECTED:	2022 - 2023 (H1) Jeep Commander This bulletin applies to vehicles built on or after September 01, 2022 (MDH 0901XX) and on or before May 10, 2023 (MDH 0510XX).	MARKET APPLICABILITY: <input type="checkbox"/> NA <input type="checkbox"/> MEA <input checked="" type="checkbox"/> SA <input type="checkbox"/> IAP <input type="checkbox"/> EE <input type="checkbox"/> CH			
CUSTOMER SYMPTOM:	<p>Customers may experience a Malfunction Indicator Lamp (MIL) illumination. Upon further investigation the technician may find that the one or more of the following Diagnostic Trouble Codes (DTCs) have been set:</p> <ul style="list-style-type: none"> • B1749-11 - FLLU Turn Light Feedback Left. • B1749-15 - FLLU Turn Light Feedback Left. • B1749-96 - FLLU Turn Light Feedback Left. • B1750-11 - FRLU Turn Light Feedback Right. • B1750-15 - FRLU Turn Light Feedback Right. • B1750-64 - FRLU Turn Light Feedback Right. <p>The customer may also comment on the following: One or both headlamps or front turn signals, are inoperable.</p> <p>NOTE: A message in the Instrument Panel Cluster (IPC) may also be displayed (Fig. 1) .

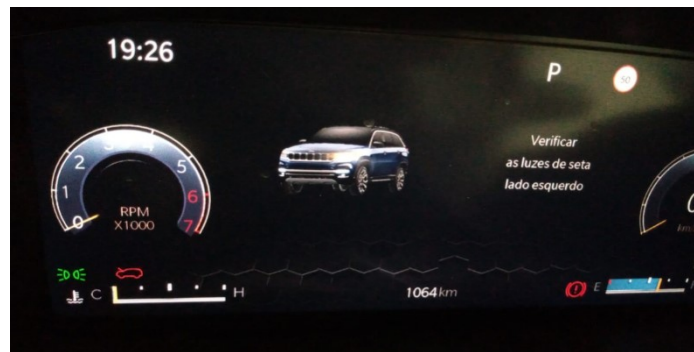
Fig. 1
IPC Message

CAUSE:	Headlamp assembly malfunction.

This bulletin involves inspecting both headlamp assemblies for functionality and if necessary, replacing the headlamp assemblies.

1. Replace the affected headlamp assembly as required. Refer to the detailed service procedures available in DealerCONNECT/Service Library under: Service Info> 08 - Electrical / 8L - Lamps and Lighting / Lamps/Lighting - Exterior / unit, Front Lamp / Removal and Installation.
2. Clear all DTCs that may have been set.
