<b>REFERENCE:</b>	<b>TSB:</b> 23-063-23 <b>GROUP</b> 23 - Body	<b>Date:</b>	June 3, 2023	<b>REVISION:</b>	23-043-22
<b>VEHICLES AFFECTED:</b>	2022 - <b>**2023**</b> (H1) Jeep Commander This bulletin applies to vehicles built on or after March 01, 2022 (MDH 0301XX) and on or before <b>**May 10, 2023 (MDH 0510XX)**</b> .	<b>MARKET APPLICABILITY:</b>			
<b>CUSTOMER SYMPTOM:</b>	Water build-up inside one or both of the headlamp assemblies (Fig. 1) .				
<b>CAUSE:</b>	Headlamp Assembly.

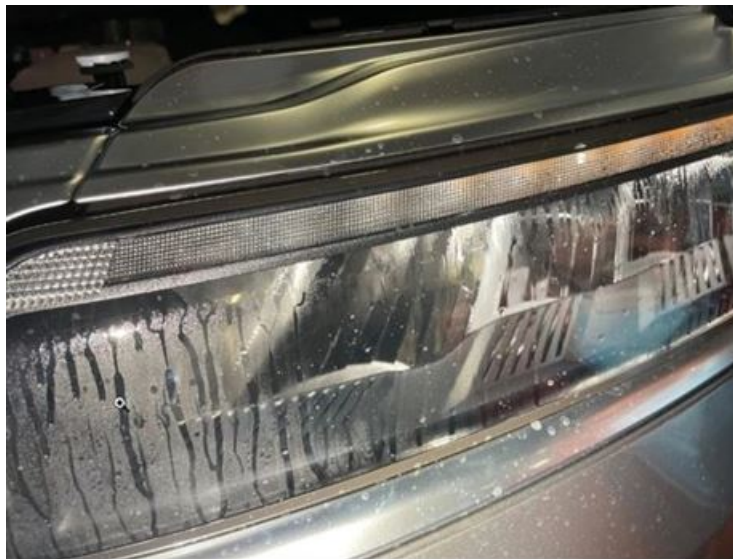
Some customers may report that water can be seen inside the headlamp assemblies (Fig. 1) .

**Fig. 1**  
**Water In The Headlamp Assembly**

This bulletin is involves inspecting and if necessary, replacing the headlamp assemblies for water intrusion.

1. Replace the affected headlamp assembly as required. Refer to the detailed service procedures available in DealerCONNECT/Service Library under: Service Info> 08 - Electrical / 8L - Lamps and Lighting / Lamps/Lighting - Exterior / unit, Front Lamp / Removal and Installation.
