Technical Service Bulletin (TSB)
Right Front Door Glass Snowflaking

REFERENCE:	TSB: 23-064-23 GROUP 23 - Body	Date:	June 7, 2023	REVISION:	-
VEHICLES AFFECTED:	2023 (WS) Grand Wagoneer/Wagoneer This bulletin applies to vehicles built on and after January 01, 2023 (MDH 0101XX) and on and before February 28, 2023 (MDH 0228XX).			MARKET APPLICABILITY:	
CUSTOMER SYMPTOM:	Bubbles or a snowflake pattern on the right front door glass.				
CAUSE:	Right front door glass contamination in the laminated layers.

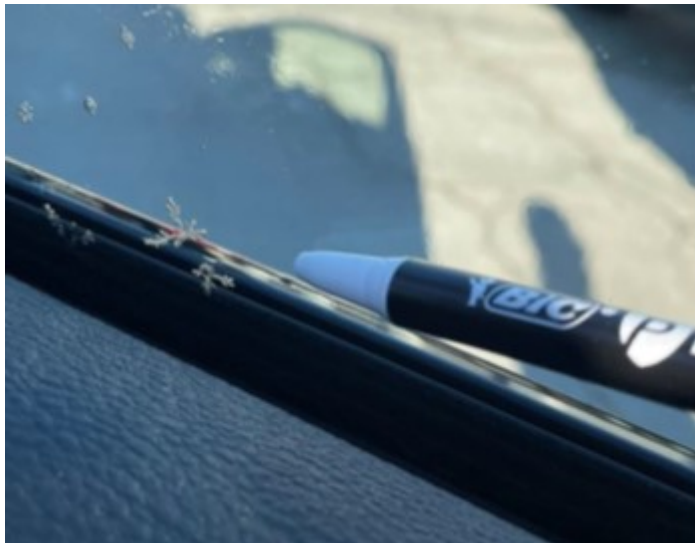
1. Inspect the right front door glass for snowflaking/bubbling. Effect is viewable from both inside and outside (Fig. 1) .

Fig. 1
Door Glass Bubbling

NOTE: Temperatures above 80° F (27° C) will accelerate the defects' appearance.

1. Replace the right front door glass. Refer to the detailed service procedures available in DealerCONNECT> Service Library under: Service Info>23 - Body / Doors - Front / Glass, Door / Removal and Installation.
