REFERENCE:	TSB: 23-067-23 GROUP 23 - Body	Date:	June 8, 2023	REVISION:	-
VEHICLES AFFECTED:	2023 (M1) Jeep Compass This bulletin applies to vehicles built on and after September 01, 2022 (MDH 0901XX) and on and before December 21, 2022 (MDH 1221XX).			MARKET APPLICABILITY: <input type="checkbox"/> NA <input type="checkbox"/> MEA <input checked="" type="checkbox"/> SA <input type="checkbox"/> IAP <input type="checkbox"/> EE <input type="checkbox"/> CH	
CUSTOMER SYMPTOM:	Roof molding has become loose or missing.				
CAUSE:	Lack of proper fixation.

This bulletin involves inspecting for missing or loose roof molding and if needed replacing missing roof molding and tightening loose retainers.

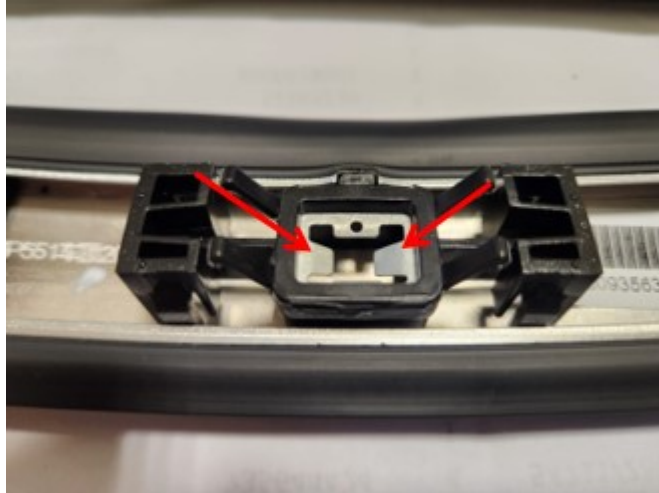
Fig. 1
Retainers Bent Out Of Position

1. Remove the roof molding, if present.
2. Ensure the roof molding retainer clips are correctly positioned.
3. Adjust the roof retainer clips to ensure molding retention. Using a flat blade screwdriver or equivalent, bend the ears/tabs of the clips upward ([Fig. 1](#)) ([Fig. 2](#)) ([Fig. 3](#)) .
