REFERENCE:	TSB: 23-066-23 GROUP 23 - Body	Date:	June 8, 2023	REVISION:	-
VEHICLES AFFECTED:	2023 (B1) Jeep Renegade This bulletin applies to vehicles built on or after October 10, 2022 (MDH 1010XX) and on or before May 10, 2023 (MDH 0510XX).	MARKET APPLICABILITY:			
CUSTOMER SYMPTOM:	The headliner as delaminating (is bubbling) (Fig. 1) .				
CAUSE:	Poor adhesion.

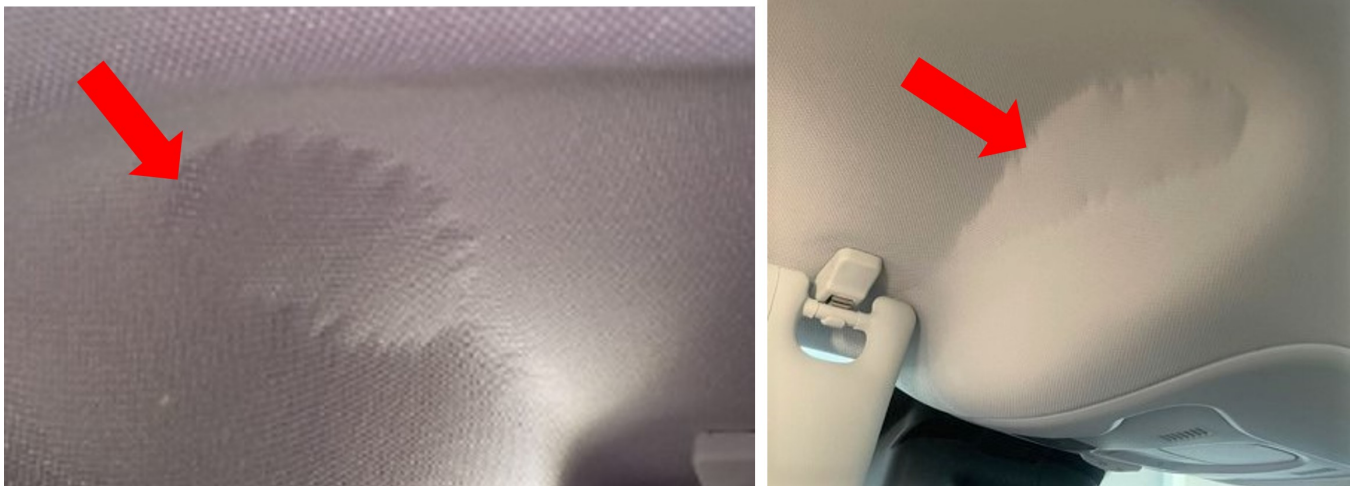
Fig. 1
Headliner Delamination (Bubbling) Examples

1. Inspect the entire headliner for and delamination (bubbling) especially near the sunvisors (Fig. 1) .
2. Was any delamination (bubbling) found on the headliner (Fig. 1) ?
 - YES>>> Proceed to [Step 1](#) of the Repair Procedure.
 - NO>>> This bulletin has been completed. Use inspect LOP (23-20-45-9M) to close the active RSU.

1. Replace the headliner. Refer to the detailed service procedures available in DealerCONNECT/Service Library under: Service Info>23 - Body / Interior / Headliner / Removal and Installation.
