STELLA **Technical Service Bulletin (TSB) Turbo to Charge Air Cooler Quick Connect Loose** PARTS & SERVICES REFERENCE: **TSB**: 09-011-23 Date: June 8, 2023 **REVISION: GROUP** 09 - Engine **VEHICLES** 2022 - 2023 (WS) Grand Wagoneer/Wagoneer MARKET APPLICABILITY: This bulletin applies to vehicles built on or after August 25, 2022 AFFECTED: \bowtie NA \square MEA (MDH 0825XX) and on or before February 17, 2023 (MDH 0217XX) □IAP □SA equipped with a 3.0L I6 Hurricane HO Twin Turbo ESS (Sales Code EFC). □EE \Box CH **CUSTOMER** Customers may experience a Malfunction Indicator Lamp (MIL) illumination. Upon further investigation SYMPTOM: the technician may find that the one or more of the following Diagnostic Trouble Codes (DTCs) have been set: • P0101 - Mass Air Flow Sensor Circuit Performance. P0236 - Turbocharger/Supercharger Boost Pressure Sensor Performance. Customers may also comment on the following:

09-011-23 -2-

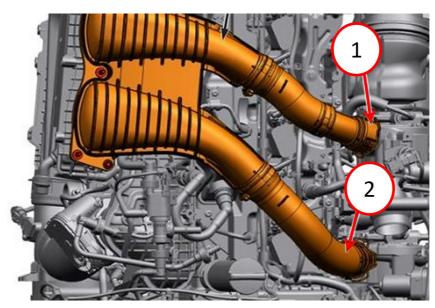
Fig. 2
Front And Rear Turbo CAC Inlet Tubes

- 1 Rear Turbo CAC Inlet Tube
- 2 Front Turbo CAC Inlet Tube (Confirm With A Push-Pull-Push Test)

- 2. Lift up and remove the engine cover (Fig. 1).
- 3. Confirm with a push-pull-push test that the charge pipe from the front/forward turbo to the Cold Air Cooler (CAC) (Fig. 2), is fully secured at the turbo and the quick connect is locked (Fig. 3). The following are examples of CACs that are not fully secure: (Fig. 4) and (Fig. 5).

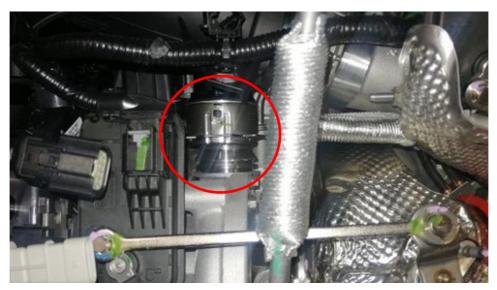
Fig. 4

Quick Connect Completely Disconnected

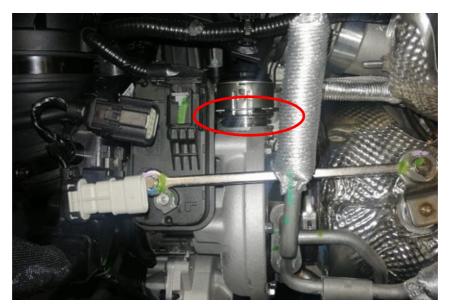
Fig. 5

Quick Connect Not Fully Seated

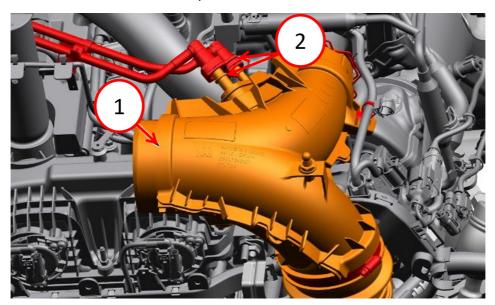
Fig. 6
Purge Hoses At Intake Air "Y" Tube

- 1 Intake Air "Y" Tube
- 2 Purge Hoses
- 5. Using wiTECH clear any DTCs that may have been set.
- 6. Install the engine cover (Fig. 1).
- 7. Install the fastener on the engine cover (Fig. 1).

4. Confirm with a push-pull-push test that both purge hoses at the intake air "Y" tube (Fig. 6), are fully secured at the intake air "Y" tube and the quick connects are locked.
