REFERENCE:	TSB: 08-138-23 GROUP 08 - Electrical	Date:	June 9, 2023	REVISION:	-
VEHICLES AFFECTED:	2022 - 2023 (WS) Grand Wagoneer/Wagoneer This bulletin applies to vehicles built on or after August 24, 2022 (MDH 0824XX) and built on or before March 08, 2023 (MDH 0308XX).		MARKET APPLICABILITY: <input checked="" type="checkbox"/> NA <input type="checkbox"/> MEA <input type="checkbox"/> SA <input type="checkbox"/> IAP <input type="checkbox"/> EE <input type="checkbox"/> CH		
CUSTOMER SYMPTOM:	<p>Customers may experience a Malfunction Indicator Lamp (MIL) illumination. Upon further investigation the technician may find that the following Diagnostic Trouble Code (DTC) have been set:</p> <ul style="list-style-type: none"> • P2AF6-00 - Starter Relay 3 Stuck Off. <p>Customers may also experience:</p> <ul style="list-style-type: none"> • Start/Stop disabled. 				
CAUSE:	Connector not fully seated.

This bulletin involves checking connector D3157A is properly connected to the Power Distribution Center (PDC).

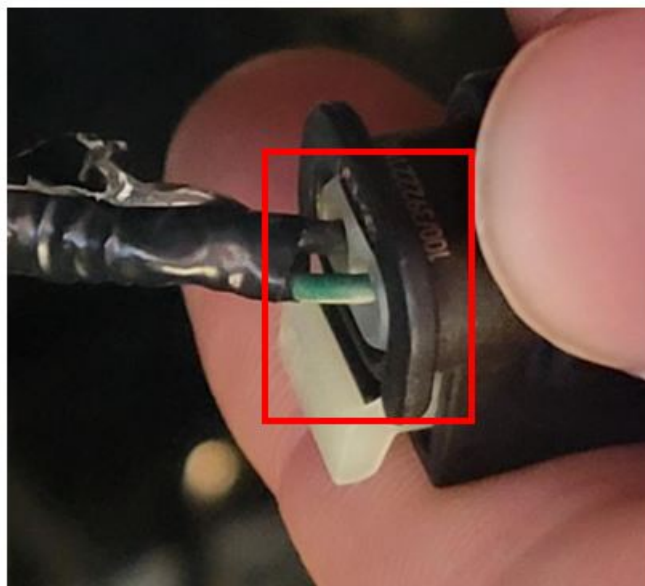
Fig. 2
Connector (D3157A) Fully Seated

3. Check if the connector D3157A is fully seated and/or connected properly to the PDC (Fig. 2) .

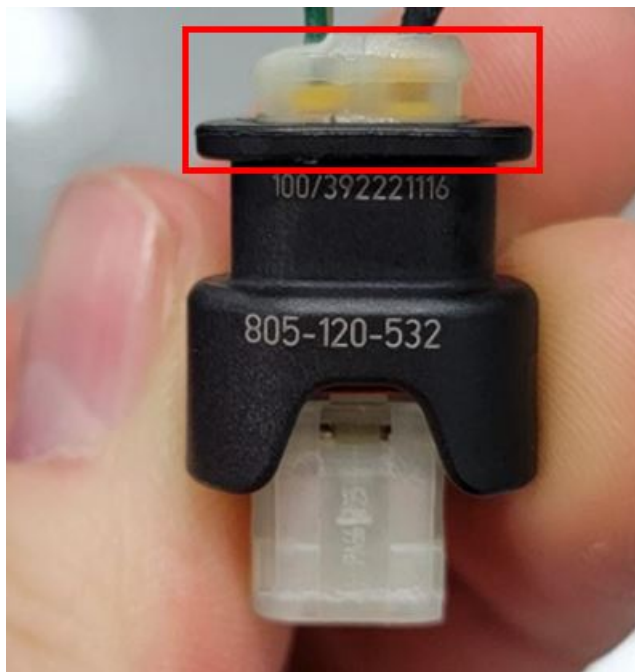
Fig. 3
Connector (D3157A) Not Fully Seated

5. If not properly seated and/or not connected to the PDC, properly reconnect D3157a to the PDC (Fig. 3) .
