REFERENCE:	TSB: 08-139-23 GROUP 08 - Electrical	Date:	June 9, 2023	REVISION:	—
VEHICLES AFFECTED:	2023 (DJ) RAM 2500 Pickup 2023 (D2) RAM 3500 Pickup 2023 (DD) RAM 3500 Cab Chassis 2023 (DF) RAM 3500 10K LB. Cab Chassis 2023 (DP) RAM 4500/5500 Cab Chassis This bulletin applies to vehicles built on and before May 20, 2023 (MDH 0520XX) equipped with Global Telematics Box Module (Sales Code RDG).			MARKET APPLICABILITY:	
CUSTOMER SYMPTOM:	Customers may experience one or more of the following: <ul style="list-style-type: none"> • Uconnect Box Message at Startup. • Uconnect Box Error Or Requires Service Message. • Connectivity: Uconnect Mobile App trunk status showing as closed when trunk is open. • Connectivity: Diagnostic Trouble Codes (DTCs) for Electronic Control Modules (ECUs) won't be shown to customer through the Vehicle Health alert (Mobile app or email). 				
CAUSE:	TBM Software

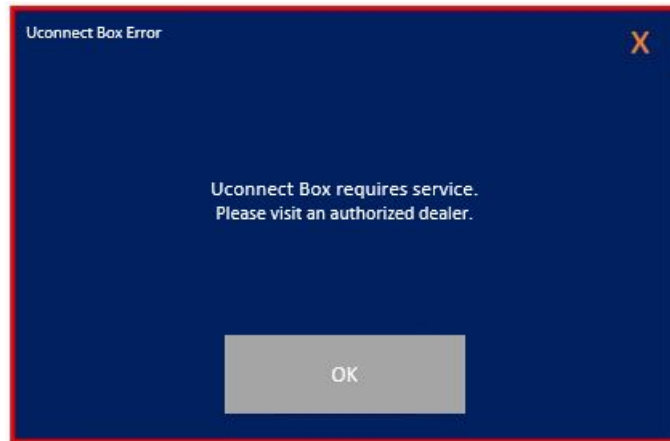
Fig. 1
Uconnect Box Error Message

Message display on the radio screen, “Uconnect Box requires service. Please visit an authorized dealer.” (Fig. 1) , with no active or stored DTCs set by the TBM.

This bulletin provides information regarding the latest Firmware Over The Air (FOTA) update and provides the service technician an overview of the steps a customer will need to take to complete the update. The TBM software will be updated from 5.25 to 5.39.1.
