REFERENCE:	TSB: 08-142-23 GROUP 08 - Electrical	Date:	June 10, 2023	REVISION:	—
VEHICLES AFFECTED:	2022 (WS) Grand Wagoneer/Wagoneer This bulletin applies to vehicles equipped with Uconnect 5 NAV W 10.1" Display (Sales Codes UBN and UEN) and Uconnect 5 W 12.0" Display (Sales Codes UBQ and UEQ).			MARKET APPLICABILITY: <input checked="" type="checkbox"/> NA <input type="checkbox"/> MEA <input type="checkbox"/> SA <input type="checkbox"/> IAP <input type="checkbox"/> EE <input type="checkbox"/> CH	
CUSTOMER SYMPTOM:	<ul style="list-style-type: none"> • Amplifier module sets Diagnostic Trouble Code (DTC) U0485 - Implausible Data Received Set. • Radio reset (Rearview camera functions normally). • Voice Recognition (VR) inoperable. • Wireless CarPlay® inoperable. • Audio sources inoperable. • Display switches to Nav on VR prompt. • Compass inop, does not update direction. • Vehicle Positioning (Lat/Long) inoperable. • Surround View Camera inoperable (Rearview camera functions normally). • Unable to exit FamCam. • Audio Repetition inoperable. • Electric vehicle pages inoperable. • Translated text is incorrect. • Profile avatar changes in Valet Mode. • Display does not return to idle mode

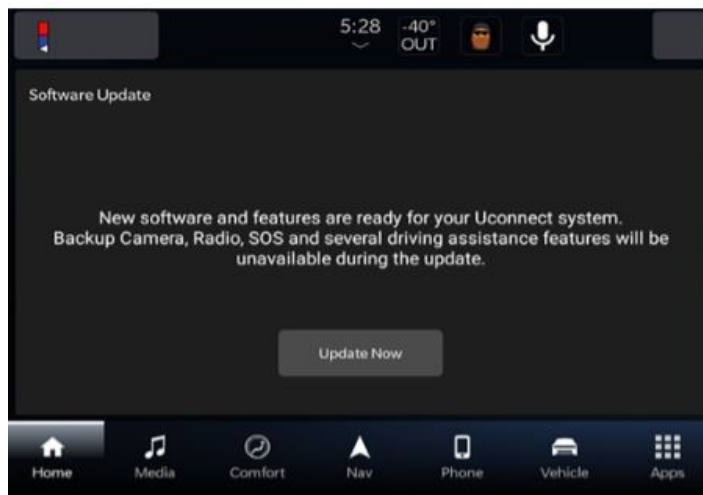
**Fig. 1
Software Acceptance Screen**

Customers will see a notification on their radio screen when new software is available for their radio (Fig. 1) . The owner will have the option to update the radio or schedule the update for later. There is not an option to decline the update indefinitely, the update must be performed.

1. The vehicle needs to be in 'Park'. The ignition needs to be in the off position.
2. If the customer selects "Update Now" they can shut off the vehicle and leave. The update will be completed automatically.

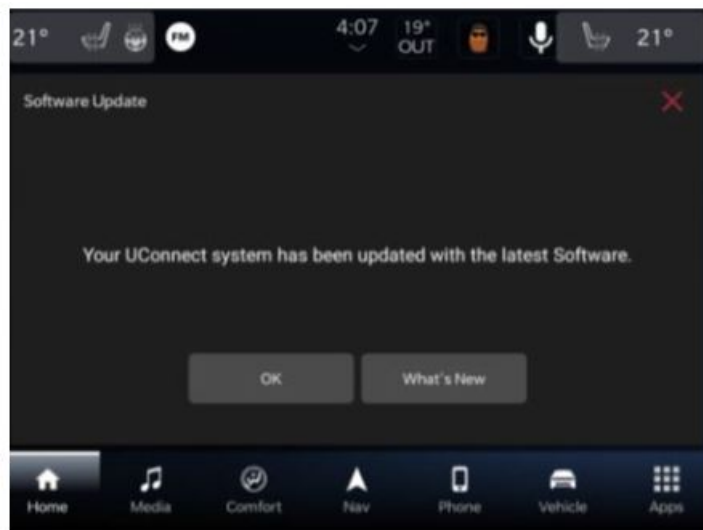
**Fig. 2
Software Update Confirmation Screen**

3. Upon completion of update, the radio will display a confirmation message (Fig. 2) .
