REFERENCE:	TSB: 08-141-23 GROUP 08 - Electrical	Date:	June 10, 2023	REVISION:	-
VEHICLES AFFECTED:	2023 (MP) Jeep Compass This bulletin applies to vehicles built on and after January 12, 2023 (MDH 0112XX) and on and before April 10, 2023 (MDH 0410XX) equipped with the 2.0L I4 DOHC DI Turbo Engine W/ESS (Sales Code EC1) and Eight Speed Automatic 8F30 Transmission (Sales Code DGD).	MARKET APPLICABILITY: <input checked="" type="checkbox"/> NA <input type="checkbox"/> CH <input type="checkbox"/> EE <input type="checkbox"/> IAP <input type="checkbox"/> SA <input type="checkbox"/> MEA			
CUSTOMER SYMPTOM:	<p>Customers may experience a Malfunction Indicator Lamp (MIL) illumination. Upon further investigation the technician may find one or more of the following Diagnostic Trouble Codes (DTCs) have been set:</p> <ul style="list-style-type: none"> • P0882 - Transmission Control Module (TCM) Power Input Signal Low. • P0883 - TCM Power Input Signal High. • P0983 - Shift Solenoid 4 Control Circuit High. • P0707 - Transmission Range Sensor "A" Circuit Low. <p>Customers may also comment on the following:</p> <ul style="list-style-type: none"> • Transmission in limp-home mode.

This bulletin invol

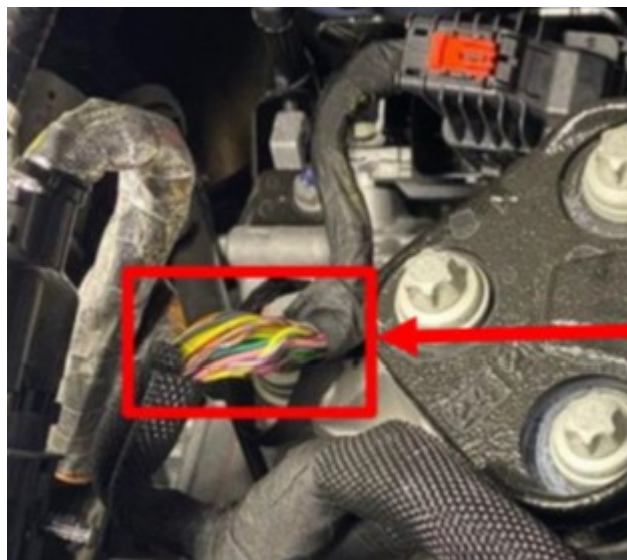
Fig. 1
TCM Harness

CAUSE:	Transmission harness possible damaged and/or wiring severed at the Powertrain Control Module (PCM).

3. Are there any damaged or severed wires in the harness (Fig. 1) ?
 - YES>>> Proceed to [Step 1](#) of the Repair Procedure.
 - NO>>> Proceed to [Step 4](#) of the Inspection Procedure.

1. Repair the TCM wiring harness. Refer to the detailed service procedures listed in DealerCONNECT>Service Library under: 28 - DTC-Based Diagnostics / Circuit Testing Procedures / Standard Procedure/Wire Splicing.
2. Install two pieces of foil backed sealing tape onto the edge of the PCM where the harness crosses over (Fig. 2) .
3. Install the PCM. Refer to the detailed service procedures listed in DealerCONNECT under: 08 - Electrical / 8E - Electronic Control Modules / Module, Powertrain Control (PCM) / Installation.
