Technical Service Bulletin (TSB)
**Water Leak (Drips) On Center Stack, Radio Or Shifter Lever From
The Front Center LH Freedom Panel**

REFERENCE:	TSB: 23-068-23 GROUP 23 - Body	Date:	June 14, 2023	REVISION:	-
VEHICLES AFFECTED:	2022 (JL) Jeep Wrangler 2022 (JT) Jeep Gladiator This bulletin applies to vehicles built on or before August 21, 2022 (MDH 0821X) equipped with Black 3-Piece Hard Top (Sales Code HTI) or Body Color 3-Piece Hard Top (Sales Code HT3).			MARKET APPLICABILITY:	
				<input checked="" type="checkbox"/> NA	<input checked="" type="checkbox"/> MEA
				<input checked="" type="checkbox"/> SA	<input checked="" type="checkbox"/> IAP
				<input checked="" type="checkbox"/> EE	<input checked="" type="checkbox"/> CH
CUSTOMER SYMPTOM:	Customers may comment on the following: <ul style="list-style-type: none"> Water is leaking on the radio coming from the left freedom top panel (Fig. 1) . 				
CAUSE:	Incorrect foam installation.

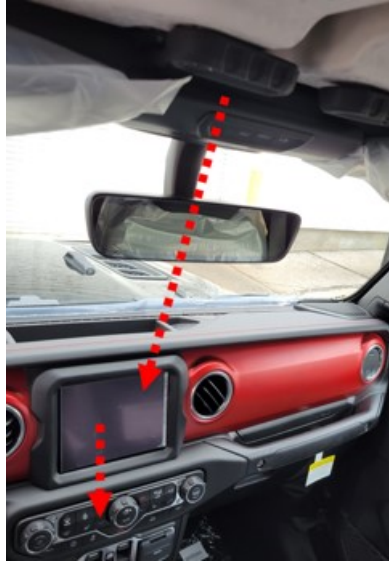
Fig. 1
Possible leaking Areas

1. Perform a water leak test. Using a water source, soak the windshield and front freedom panel roof area with water.

2. Did the water leak inside the cabin at the front center area (Fig. 1) ?
 - YES>>> Proceed to [Step 3](#).
 - NO>>> This bulletin has been completed, use inspect LOP (23-50-59-92) to close the active RSU.
3. Check freedom panel gap/flush at front receivers. Refer to the detailed service procedures available in DealerCONNECT> Service Library under: Service Info>23 - Body / Removable Top, Hard / Standard Procedure Freedom Panel Flushness Instructions.
4. Verify the freedom panel center seal is not damaged and in the proper location. Verify the center seal is not pinched between the freedom panels (Fig. 2) .

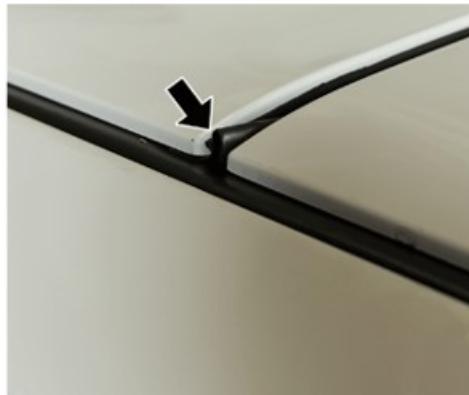
Fig. 2
Center Seal Pinched between Freedom Panels

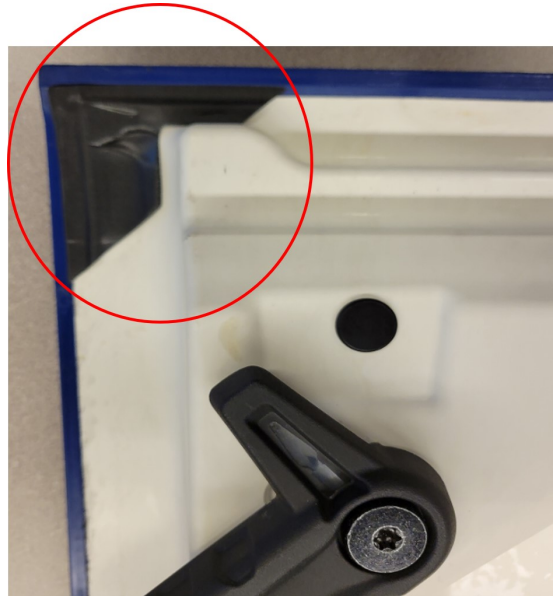
Fig. 3
Incorrectly Installed Foam

6. Remove the old foam from the front inner corner of the LH panel and wipe clean with isopropyl alcohol to prep the surface for the new foam installation. (Fig. 3) .

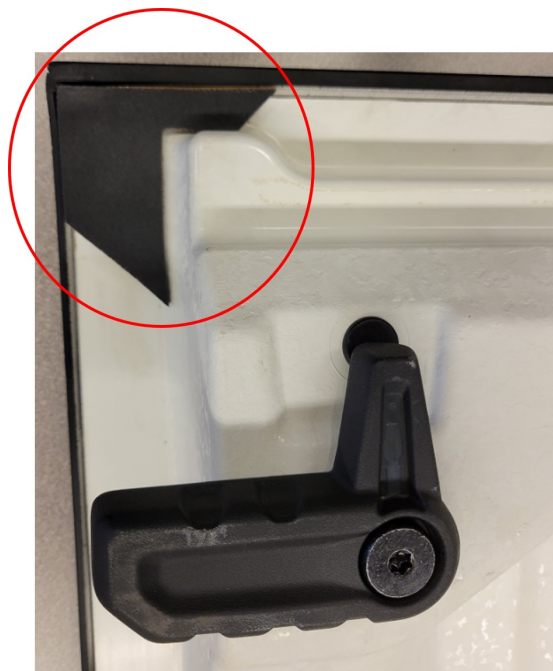
Fig. 4
Correctly Installed Foam

7. Install new foam pad at the front center of the left freedom panel (Fig. 4) .

8. Firmly press the entire foam pad down to promote full adhesion (Fig. 4) .
9. Install the left freedom panel on the vehicle.
10. Perform water test to verify repair.
11. Did the repair stop the leak?
 - YES>>> This bulletin is completed.
 - NO>>> Further diagnosis should be performed.
