Technical Service Bulletin (TSB)
Diagnostic Trouble Code (DTC) P1CEA

REFERENCE:	TSB: 25-002-23 GROUP 25 - Emissions Control	Date:	June 15, 2023	REVISION:	-
VEHICLES AFFECTED:	2022 - 2023 (WL) Jeep Grand Cherokee This bulletin applies to vehicles built on or before January 31, 2023 (MDH 0131XX) equipped with 2.0L I4 DOHC DI Turbo PHEV Engine (Sales Code ECX).	MARKET APPLICABILITY:			
		<input checked="" type="checkbox"/> NA <input type="checkbox"/> EE <input type="checkbox"/> SA		<input checked="" type="checkbox"/> IAP <input type="checkbox"/> MEA <input type="checkbox"/> CH	
CUSTOMER SYMPTOM:	Customers may experience a Malfunction Indicator Lamp (MIL) illumination. Upon further investigation the technician may find the following Diagnostic Trouble Code (DTC) has been set: <ul style="list-style-type: none"> P1CEA - Boost Side EVAP Purge System Performance. 				
CAUSE:	EVAP vacuum lines not fully secured.

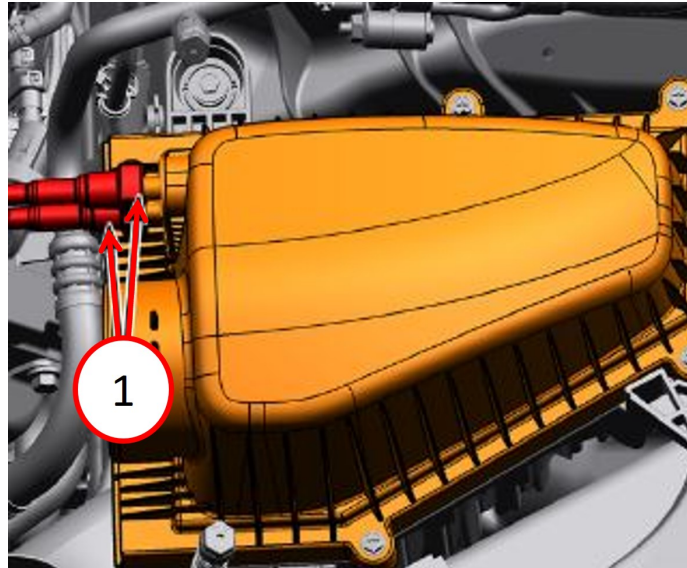
Fig. 1

Two EVAP Line Quick Connects At The Air Cleaner Cover

1 - Two EVAP Line Quick Connects

1. Open the hood.
2. Inspect the two EVAP line quick connects at the air cleaner cover (Fig. 1) by pressing the white connector lock (Fig. 2) and with a push-pull-push test, ensure both quick connect locks are locked (Fig. 2) .

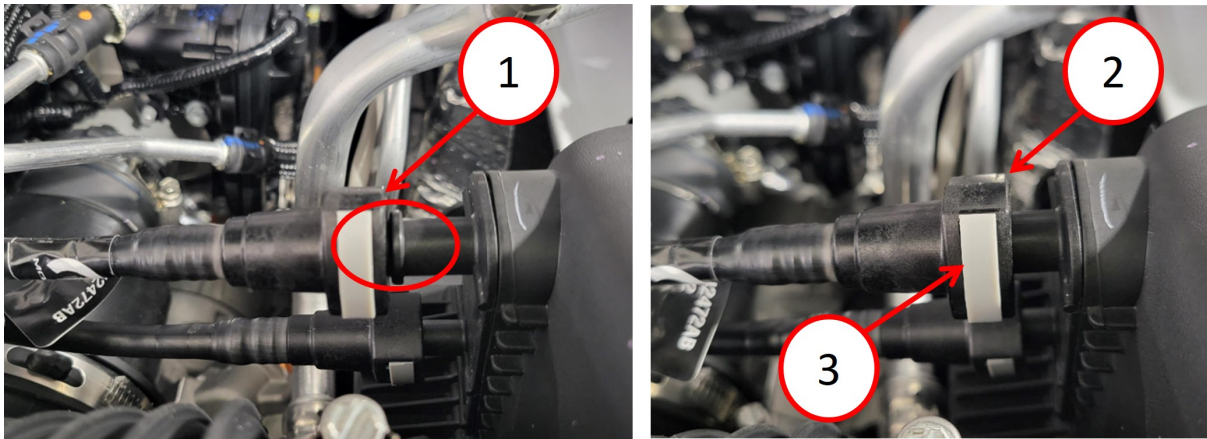
Fig. 2

Unlocked And Locked EVAP Quick Connects

- 1 - EVAP Quick Connector **NOT** Locked (Lock Ring Is Visible)
- 2 - EVAP Quick Connector Seated And Locked
- 3 - White Connector Lock
