Technical Service Bulletin (TSB)
Loose or Missing Front Roof Ditch Molding

REFERENCE:	TSB: 23-065-23 GROUP 23 - Body	Date:	June 15, 2023	REVISION:	-
VEHICLES AFFECTED:	2022 - 2023 (WS) Grand Wagoneer/Wagoneer This bulletin applies to vehicles built on or after February 15, 2021 (MDH 0215XX) and on or before November 15, 2022 (MDH 1115XX).	MARKET APPLICABILITY:			
		<input checked="" type="checkbox"/> NA		<input type="checkbox"/> CH	
		<input type="checkbox"/> EE		<input type="checkbox"/> IAP	
		<input type="checkbox"/> SA		<input type="checkbox"/> MEA	
CUSTOMER SYMPTOM:	Loose or missing front roof ditch molding.				
CAUSE:	Front roof ditch molding clips.

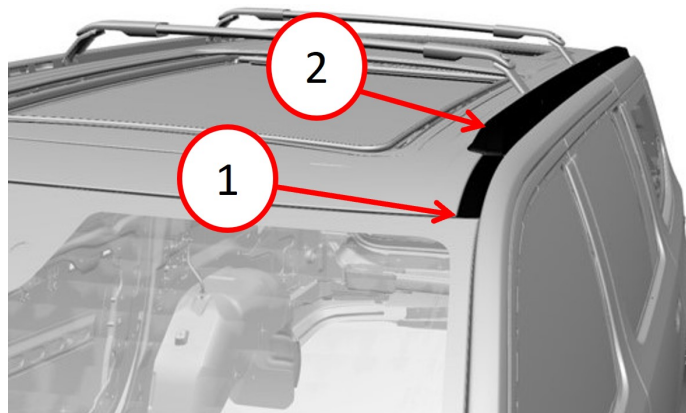
**Fig. 1
Front And Rear Roof Ditch Moldings**

NOTE: This inspection procedure only involves inspecting the front, smaller roof ditch moldings. Do not inspect the rear, longer roof ditch moldings (Fig. 1) .

1. Inspect both front roof ditch moldings (Fig. 1) for looseness by grabbing the molding with your hand.

NOTE: There should be little to no movement with the moldings.

- 1 - Front Roof Ditch Molding (Inspect This Molding ONLY)
- 2 - Rear Roof Ditch Molding (DO NOT Inspect This Molding)

2. Were one or both front roof ditch moldings (Fig. 1) loose, missing or could be detached from the roof?
 - YES>>> Replace the front ditch moldings as required. Proceed to Step 1 of the Repair Procedure.
 - NO>>> This bulletin has been completed. Use inspect LOP (23-02-67-93) to close the active RSU.

1. Using a trim stick, remove the old front ditch molding(s) as required. Refer to the detailed service procedures available in DealerCONNECT> Service Library under: Service Info>23 - Body / Exterior / Molding, Roof Joint / Removal.
2. Prepare the paint and varnish in the ideal proportions according to the manufacturer. Test first in an appropriate place to check the color tone of the paint. **Determine which type of basecoat will be used solvent or waterborne based:**
