## Technical Service Bulletin (TSB) Chirp Noise From Third Row Seat Headrest

<b>REFERENCE:</b>	<b>TSB:</b> 23-069-23 <b>GROUP</b> 23 - Body	<b>Date:</b>	June 15, 2023	<b>REVISION:</b>	-
<b>VEHICLES AFFECTED:</b>	2022 - 2023 (WD) Dodge Durango This bulletin applies to vehicles built on or after July 29, 2022 (MDH 0729XX) and on and before March 23, 2023 (MDH 0323XX).		<b>MARKET APPLICABILITY:</b>		
			<input checked="" type="checkbox"/> NA	<input checked="" type="checkbox"/> MEA	
			<input checked="" type="checkbox"/> SA	<input type="checkbox"/> IAP	
			<input checked="" type="checkbox"/> EE	<input type="checkbox"/> CH	
<b>CUSTOMER SYMPTOM:</b>	Chirp noise from third row seat headrest.				
<b>CAUSE:</b>	Grease not applied to the correct area.

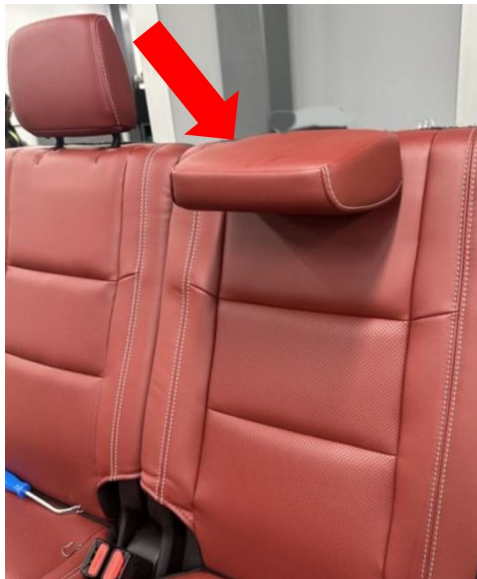
**Fig. 1**  
**Third Row Seat Assembly**

1. Open the liftgate.
2. Ensure the third row seat back is in the upright locked position (Fig. 1) .

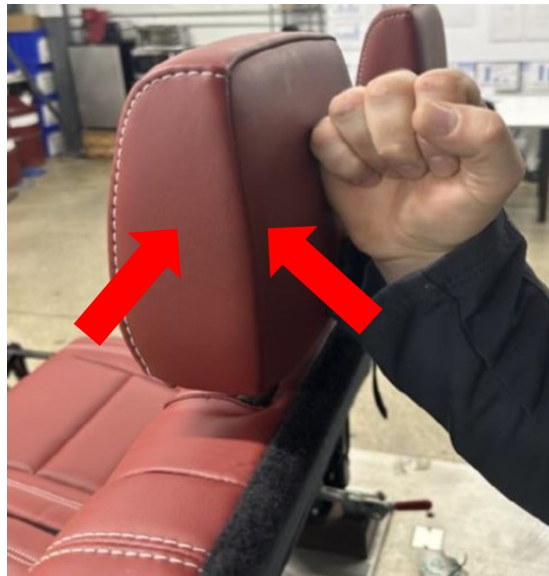
**Fig. 2**  
**Headrest Checks**

3. Ensure headrest is in the upright locked position (Fig. 1) .
4. Using fist, pound on the back of the headrest a minimum of five times (Fig. 2) .

5. Using fist, pound on the side of the headrest a minimum of five times (Fig. 2) .
6. Was a chirp noise heard from either third row seat headrest (Fig. 2) ?
  - YES>>> Proceed to [Step 1](#) of the Repair Procedure.
  - NO>>> This bulletin has been completed, close the liftgate. Use inspect LOP (23-13-25-91) to close the active RSU.
