Technical Service Bulletin (TSB)
Right Side Tailgate Not Flush with Cargo Box

| REFERENCE: | TSB: 23-071-23 GROUP 23 - Body | Date: | June 16, 2023 | REVISION: | - |
| VEHICLES AFFECTED: | 2023 (JT) Jeep Gladiator This bulletin applies to vehicles built on or after March 05, 2023 (MDH 0305XX) and on or before March 11, 2023 (MDH 0311XX). | MARKET APPLICABILITY: | | | |

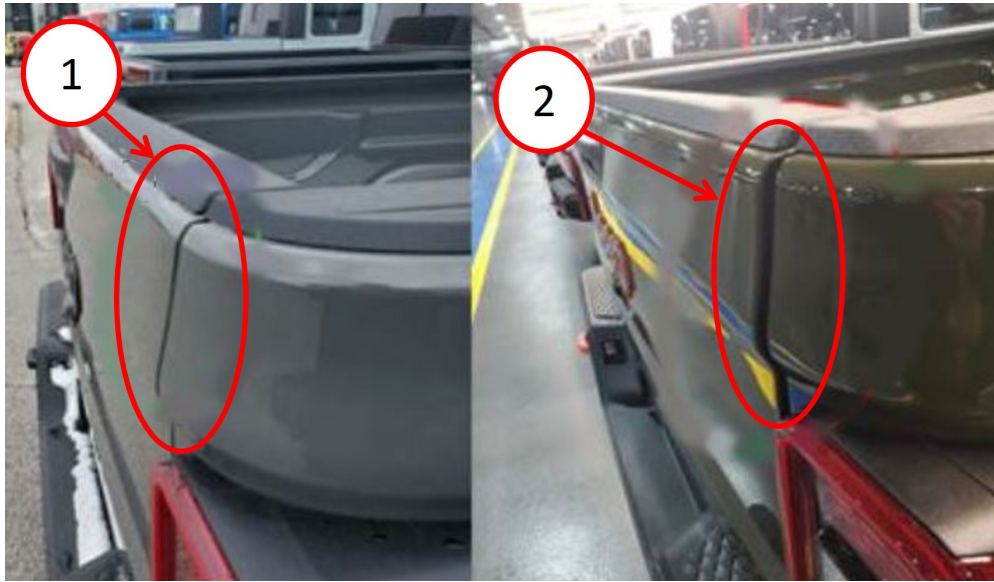
Fig. 1

Correct And Incorrect Right Side Tailgate Gaps

- 1 - Correct Right Side Tailgate Flush Gap With Cargo Box
 2 - Incorrect Right Side Tailgate Flush Gap With Cargo Box

3. Was there an uneven gap ([Fig. 1](#)) on the right side of the tailgate to the cargo box?
 - YES>>> Proceed to [Step 1](#) of the Repair Procedure.
 - NO>>> This bulletin has been completed. Use inspect LOP (23-41-04-9A) to close the active RSU.
