| REFERENCE: | TSB: 23-070-23 GROUP 23 - Body | Date: | June 16, 2023 | REVISION: | - |
| VEHICLES AFFECTED: | 2023 (WD) Dodge Durango This bulletin applies to vehicles built on and after March 10, 2023 (MDH 0310XX) and on and before March 14, 2023 (MDH 0314XX). | | | MARKET APPLICABILITY: | |
| CAUSE: | Liftgate striker too far forward in vehicle. | | | | |

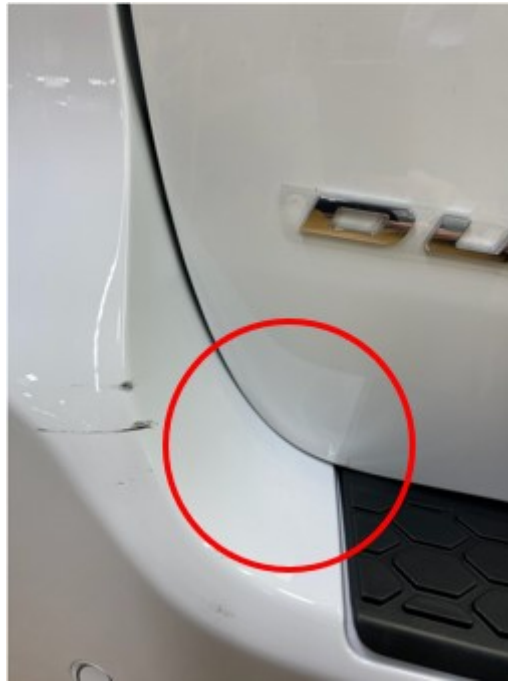
1. Inspect liftgate alignment and operation (Fig. 1) , (Fig. 2) .

Fig. 1
Left Gap Too Tight

1. Adjust the liftgate. Refer to the detailed service procedures listed in DealerCONNECT>Service Library under: 23 - Body / Decklid/Hatch/Liftgate/Tailgate/Swing Gate / Liftgate / Adjustments/ In/Out Adjustment/ Lower.
2. Verify the liftgate gap is correct. This bulletin has been completed. Use LOP (23-19-04-91) to close the active RSU.

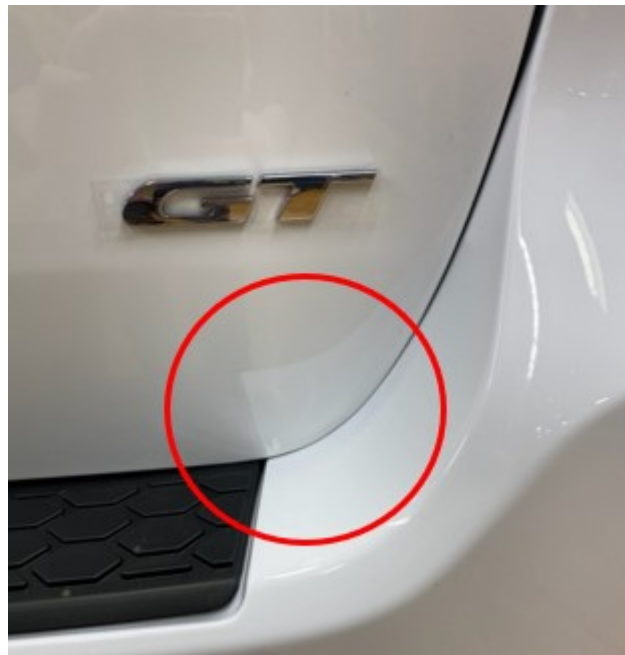
Fig. 2
Right Gap Too Tight

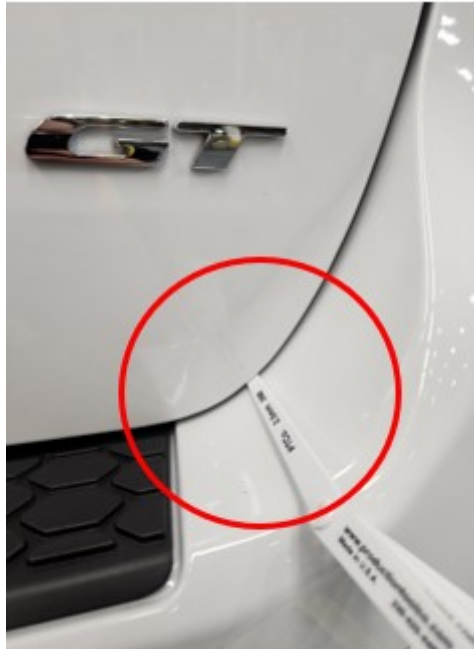
- 2. Is the liftgate hard to close and/or is the gap too tight? Check the gap between the liftgate and body. The gap should be 4.0mm +/-2mm. (.158" +/-0.078")(Fig. 3) .

Fig. 3
2.5mm Feeler Gauge
