<b>REFERENCE:</b>	<b>TSB:</b> 08-148-23 <b>GROUP</b> 08 - Electrical	<b>Date:</b>	June 17, 2023	<b>REVISION:</b>	-
<b>VEHICLES AFFECTED:</b>	<b>2023 (GG) Dodge Hornet</b> This bulletin applies to vehicles built on or before May 30, 2023 (MDH 0530XX).	<b>MARKET APPLICABILITY:</b>			
		<input checked="" type="checkbox"/> NA <input type="checkbox"/> MEA <input type="checkbox"/> SA <input type="checkbox"/> IAP <input type="checkbox"/> EE <input type="checkbox"/> CH			
<b>CUSTOMER SYMPTOM:</b>	<p>Customers may experience a Malfunction Indicator Lamp (MIL) illumination. Upon further investigation the technician may find that the following DTC has been set:</p> <ul style="list-style-type: none"> <li>C0529-00 - Steering Angle Sensor Module Missing Calibration - No Subtype Information.</li> </ul> <p>The customer may experience the following:</p> <ul style="list-style-type: none"> <li>During a key OFF and ON action, rotating the steering wheel without any power assist, the Malfunction Indicator Light (MIL) ON will be activated due to a loss of calibration of the steering angle sensor. After turning the steering wheel lock to lock, the MIL will be switched off.</li> </ul>

<b>CAUSE:</b>	EPS s

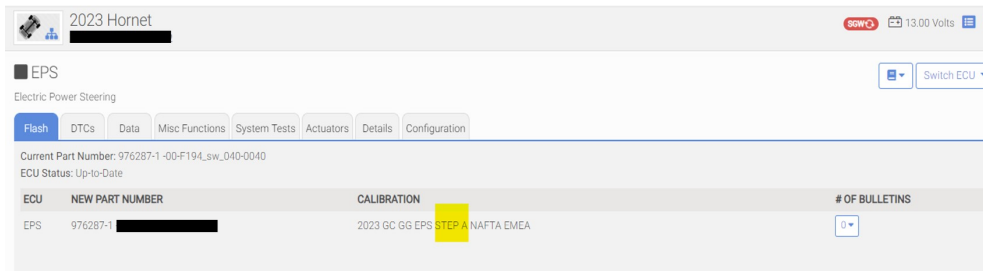
**Fig. 1**  
**Example of wiTECH Step Flashes**

**CAUTION! Multiple step flashes up to three may be necessary and are required to completely update this EPS these must be performed in order starting with STEP C, be sure to follow wiTECH accordingly (Fig. 1) .**

3. **Select the appropriate software per wiTECH (Step C, B or A) either Step C or B must be done first in order and end with Step A when finished.**
4. Reprogram the EPS module with the latest software. Detailed instructions for flashing control modules using the wiTECH Diagnostic Application are available by selecting the application’s “HELP” tab.
5. Wait 2 minutes after the EPS flash has been completed.
6. To perform an EPS reset with wiTECH - Go to the Guided Diagnostics menu --> Select Reset ECU --> Select "EPS" from the list of modules --> Click "Continue" at the bottom of the page then follow the wiTECH prompts.
