REFERENCE:	TSB: 17-001-23 GROUP 17 - Rear Suspension	Date:	June 17, 2023	REVISION:	-
VEHICLES AFFECTED:	2023 (JL) Jeep Wrangler This bulletin applies to vehicles built on or after April 14, 2023 (MDH 0414XX) and on or before April 25, 2023 (MDH 0425XX).	MARKET APPLICABILITY:			
		<input checked="" type="checkbox"/> NA		<input checked="" type="checkbox"/> MEA	
		<input checked="" type="checkbox"/> SA		<input checked="" type="checkbox"/> IAP	
		<input checked="" type="checkbox"/> EE		<input type="checkbox"/> CH	
CUSTOMER SYMPTOM:	The customer or technician may comment on possible missing rear jounce bumper(s) from the mounting perch.				
CAUSE:	Jounce bumper(s) missing from the rear mounting perch.

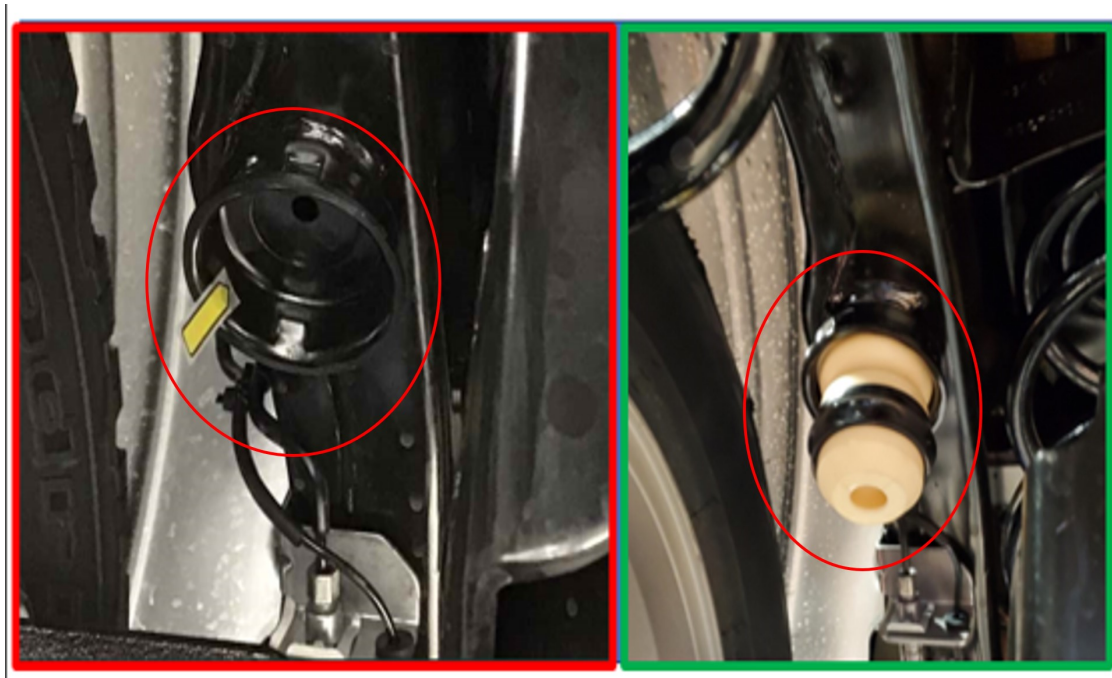
Fig. 1

1. Raise and support the vehicle. Refer to the detailed service procedures available in DealerCONNECT>Service Library under: Service Info 04 - Vehicle Quick Reference / Hoisting / Standard Procedure.
2. Inspect for missing rear jounce bumpers (Fig. 1) .
3. Are one or both rear jounce bumpers missing? (Fig. 1)
 - YES >>> Proceed to [Step 4](#).
 - NO >>> This bulletin has been completed, use inspect LOP (02-30-04-93) to close the active RSU. Proceed to [Step 5](#).

Picture Of The Rear Jounce Bumper Both Missing And Properly Installed In The Mounting Perch

4. Install the missing rear jounce bumper(s). Refer to the detailed service procedures available in DealerCONNECT> Service Library under: Service Info> 17 - Rear Suspension / Bumper, Jounce / Installation.
5. Lower the vehicle from the hoist. Refer to the detailed service procedures available in DealerCONNECT>Service Library under: Service Info 04 - Vehicle Quick Reference / Hoisting / Standard Procedure.
