REFERENCE:	TSB: 23-067-23 REV. A GROUP 23 - Body	Date:	June 20, 2023	REVISION:	-
VEHICLES AFFECTED:	2023 (M1) Jeep Compass This bulletin applies to vehicles built on and after ** August 20, 2022 (MDH 0820XX) and on and before April 20, 2023 (MDH 0420XX).**		MARKET APPLICABILITY: <input type="checkbox"/> NA <input type="checkbox"/> MEA <input checked="" type="checkbox"/> SA <input type="checkbox"/> IAP <input type="checkbox"/> EE <input type="checkbox"/> CH		
CUSTOMER SYMPTOM:	Roof molding has become loose or missing.				
CAUSE:	Lack of proper fixation.

This bulletin involves inspecting for missing or loose roof molding and if needed replacing missing roof molding and tightening loose retainers.

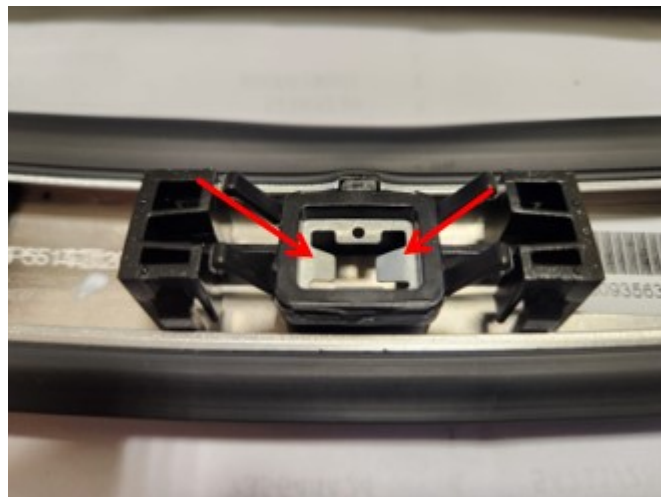
Fig. 1
Retainers Bent Out Of Position

1. Remove the roof molding, if present.
2. Ensure the roof molding retainer clips are correctly positioned.
3. Adjust the roof retainer clips to ensure molding retention. Using a flat blade screwdriver or equivalent, bend the ears/tabs of the clips upward ([Fig. 1](#)), ([Fig. 2](#)) & ([Fig. 3](#)).

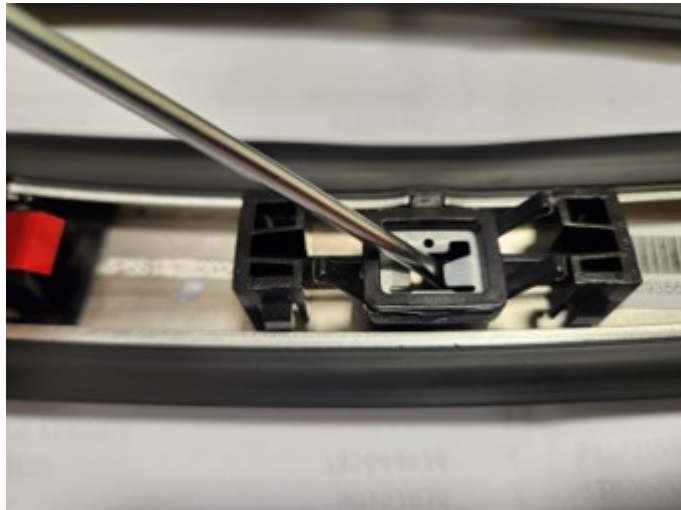
Fig. 2
Correcting Retainer positioning

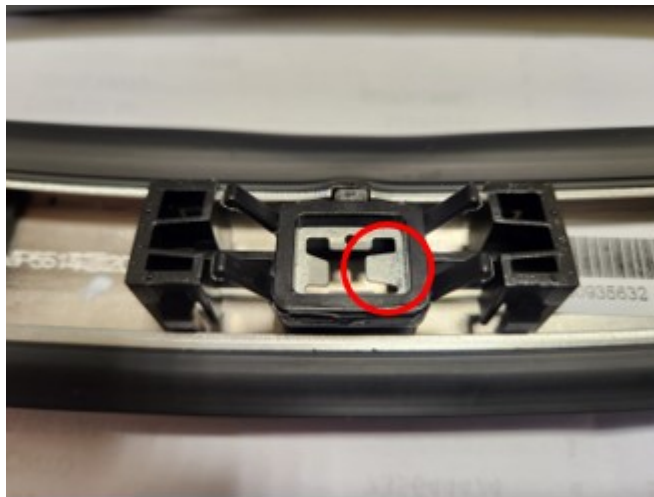
Fig. 3
Retainer Correctly Positioned
