REFERENCE:	TSB: 08-151-23 GROUP 08 - Electrical	Date:	June 21, 2023	REVISION:	—
VEHICLES AFFECTED:	2023 (DT) RAM 1500 Pickup 2023 (DS) RAM 1500 Pickup This bulletin applies to (DT) vehicles built on and before June 27, 2023 (MDH 0627XX) and (DS) vehicles built on and before June 05, 2023 (MDH 0605XX) equipped with Global Telematics Box Module (Sales Code RDG).			MARKET APPLICABILITY:	
CUSTOMER SYMPTOM:	Customers may experience one or more of the following: <ul style="list-style-type: none"> • Uconnect Box Message at Startup. • Uconnect Box Error Or Requires Service Message. • Connectivity: Uconnect Mobile App trunk status showing as closed when trunk is open. • Connectivity: Diagnostic Trouble Codes (DTCs) for Electronic Control Modules (ECUs) won't be shown to customer through the Vehicle Health alert (Mobile app or email). 				
CAUSE:	TBM Software

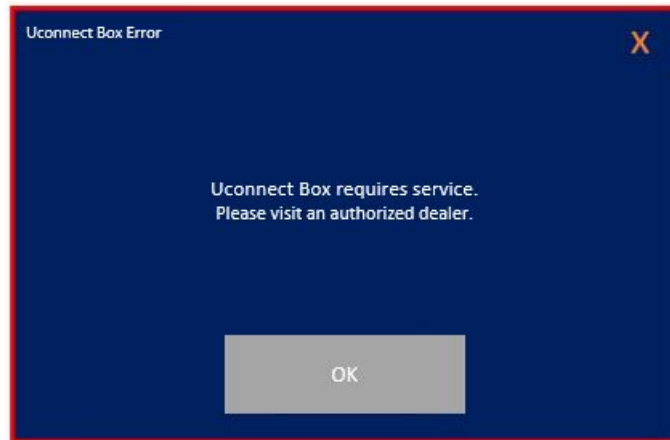
Fig. 1
Uconnect Box Error Message

Message display on the radio screen, “Uconnect Box requires service. Please visit an authorized dealer.” (Fig. 1) , with no active or stored DTCs set by the TBM.

This bulletin provides information regarding the latest Firmware Over The Air (FOTA) update and provides the service technician an overview of the steps a customer will need to take to complete the update. The TBM software will be updated from 5.25 to 5.39.1.
