REFERENCE:	TSB: 23-076-23 GROUP 23 - Body	Date:	June 23, 2023	REVISION:	23-046-22
VEHICLES AFFECTED:	2020 - **2023** (JL) Jeep Wrangler This bulletin applies to vehicles built on or before **April 15, 2023 (MDH 0415XX)** equipped with Sky One-Touch Power Top (Sales Code STJ). **The RSU part of this bulletin pertains to vehicle built on or after October 13, 2022 (MDH 1013XX) and build on or before April 15, 2023 (MDH 0415XX).**			MARKET APPLICABILITY:	
				<input checked="" type="checkbox"/> NA	<input type="checkbox"/> CH
				<input checked="" type="checkbox"/> **EE	<input checked="" type="checkbox"/> IAP
				<input type="checkbox"/> SA	<input checked="" type="checkbox"/> MEA**
CUSTOMER SYMPTOM:	A rattle noise over bumps and rough roads while driving coming from the roof area.				
CAUSE:	Loose power top fasteners.

This bulletin supersedes Technical Service Bulletin (TSB) 23-046-22, date of issue October 28, 2022, which should be removed from your files. All revisions are highlighted with ****asterisks**** and include additional model year, markets, build dates, update to RSU status, repair steps.

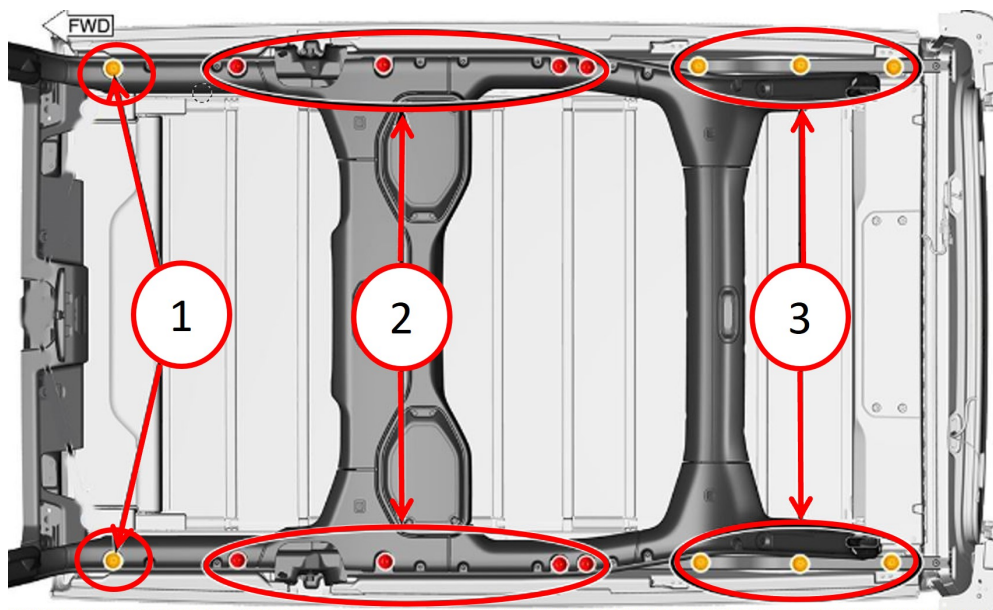
Fig. 1

NOTE: Typically one or more of the 16 attaching screws will be loose.

Locations Of 16 Power top Screws

- 1 - Front Screws 70 mm (2.75 in.) Screw Length (Yellow Locations)
- 2 - Middle Screws 103 mm (4 in.) Screw Length (Red Locations)
- 3 - Rear Door Opening Screws 70 mm (2.75 in.) Screw Length (Yellow Locations)

1. Is the vehicle on the RSU VIN list?
 - YES>>> Proceed to [Step 4](#).
 - NO>>> Proceed to [Step 2](#).
2. Verify that all 16 screws are properly tighten.
3. Were any on the screw **not** tighten properly?
 - YES>>> Proceed to [Step 4](#).
 - NO>>> This bulletin does not apply. Normal diagnostic should be performed.
4. Replace all 16 screws.** ([Fig. 1](#)) .

NOTE: Use P/N 06513816AA for Rear Aperture and Front screws (Yellow Locations ([Fig. 1](#))) and P/N 06513815AA for Body screws (Red Locations ([Fig. 1](#))).

- 5 N·m (44 in. lbs.) - Power top assy to body screws.
- 6 N·m (53 in. lbs.) - Power top assy to body screws at B-pillar.
- 6 N·m (53 in. lbs.) - Power top assy to body screws at rear aperture.
