Technical Service Bulletin (TSB)

Fuel Pump Connector Replacement

REFERENCE:	TSB : 08-152-23 GROUP 08 - Electrical	Date:	June 23, 2023	REVISION :	08-032-17
VEHICLES AFFECTED:	**2010** - 2016 (LX) Chrysler 300 2011 - 2016 (LD) Dodge Charger 2015 - 2016 (LA) Dodge Challenger **2010** - 2014 (LC) Dodge Challenger			MARKET AF	PLICABILITY: ⊠MEA □IAP □CH
CUSTOMER SYMPTOM:	The technician may experience a crank/no start after the fuel pump module was replaced.				
CAUSE:	Updated fuel pump and connector

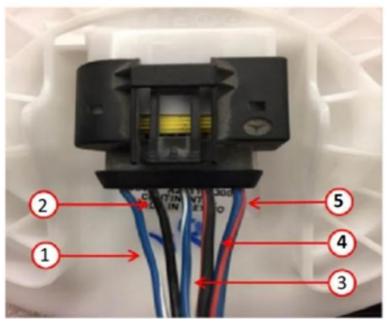
Fig. 1 Old Harness Connector (LA/LD/LX)

When replacing the fuel pump module for any reason, the revised fuel pump kit will come with an updated harness connector. The harness connector **MUST** be replaced, even if there are no issues with the old connector. The new pump has the electrical terminals (pins) in different locations, as shown in (**Fig. 1), (Fig. 2) and (Fig. 3).

- 1 Fuel level signal 2
- 2 Fuel level sense return
- 3 Fuel level sensor signal
- 4 Fuel pump ground (-)
- 5 Fuel pump control output (B+)

This bulletin involves replacing the fuel pump connector harness (pigtail) when replacing the fuel pump module.

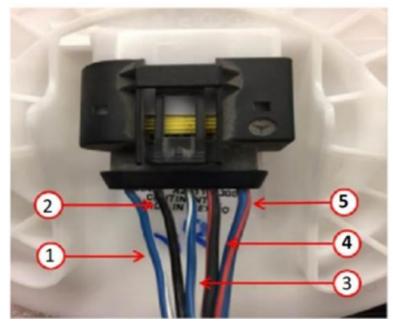
Fig. 2 Old Harness Connector (LC)

- 1 Fuel level sensor signal
- 2 Ground (-)
- 3 Fuel level signal 2
- 4 Fuel pump ground (-)
- 5 Fuel pump control output (B+)
