Technical Service Bulletin (TSB) Right Front Door Glass Snowflaking

REFERENCE:	TSB: 23-075-23 GROUP 23 - Body	Date:	June 23, 2023	REVISION:	-
VEHICLES AFFECTED:	2023 (WL) Jeep Grand Cherokee This bulletin applies to vehicles built on and after January 01, 2023 (MDH 0101XX) and on and before February 28, 2023 (MDH 0228XX).			MARKET APPLICABILITY:	
				<input checked="" type="checkbox"/> NA	<input checked="" type="checkbox"/> CH
				<input checked="" type="checkbox"/> EE	<input checked="" type="checkbox"/> IAP
				<input checked="" type="checkbox"/> SA	<input checked="" type="checkbox"/> MEA
CUSTOMER SYMPTOM:	Bubbles or a snowflake pattern on the right front door glass.				
CAUSE:	Manufacturing defect of the right front door glass leading to contamination in the laminated layers.

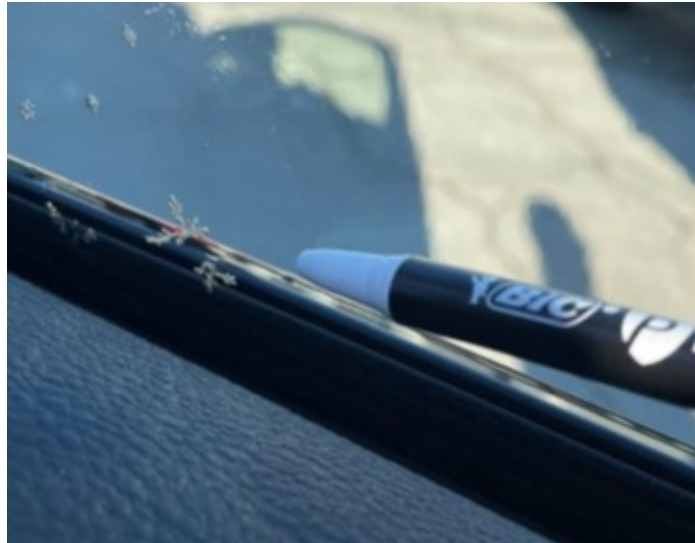
1. Inspect right front door glass for snowflaking/bubbling. Effect is viewable from both inside and outside (Fig. 1) .

Fig. 1
Door Glass Bubbling

NOTE: Temperatures above 80° F (27° C) will accelerate the defects' appearance.

1. Replace the right front door glass. Refer to the detailed service procedures available in DealerCONNECT> Service Library under: Service Info>23 - Body / Doors - Front / Glass, Door / Removal and Installation.
