<b>REFERENCE:</b>	<b>TSB:</b> 23-078-23 <b>GROUP</b> 23 - Body	<b>Date:</b>	June 27, 2023	<b>REVISION:</b>	-
<b>VEHICLES AFFECTED:</b>	<b>2023 (B1) Jeep Renegade</b> This bulletin applies to vehicles built on and after March 24, 2023 (MDH 0324XX) and on and before May 25, 2023 (MDH 0525XX).	<b>MARKET APPLICABILITY:</b>			
		<input type="checkbox"/> NA		<input type="checkbox"/> CH	
		<input type="checkbox"/> EE		<input type="checkbox"/> IAP	
		<input checked="" type="checkbox"/> SA		<input type="checkbox"/> MEA	
<b>CUSTOMER SYMPTOM:</b>	Excessive noise in the rear of the vehicle.				
<b>CAUSE:</b>	Cargobox missing (Fig. 1).

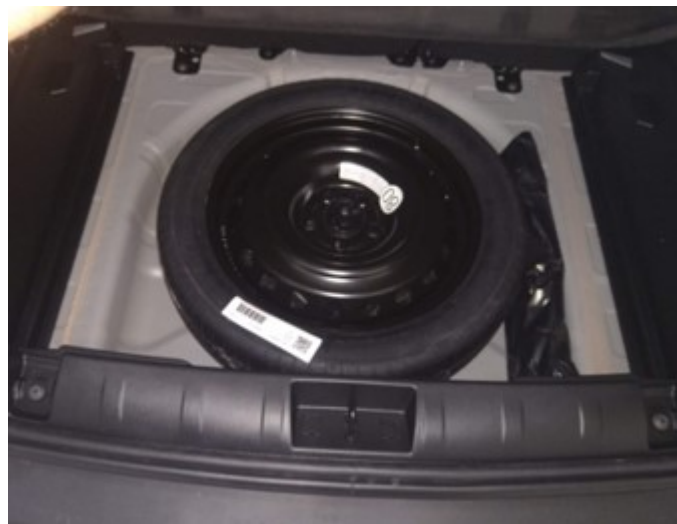
**Fig. 1**  
**Cargobox Missing**

This bulletin involves adding the cargobox to the vehicle.

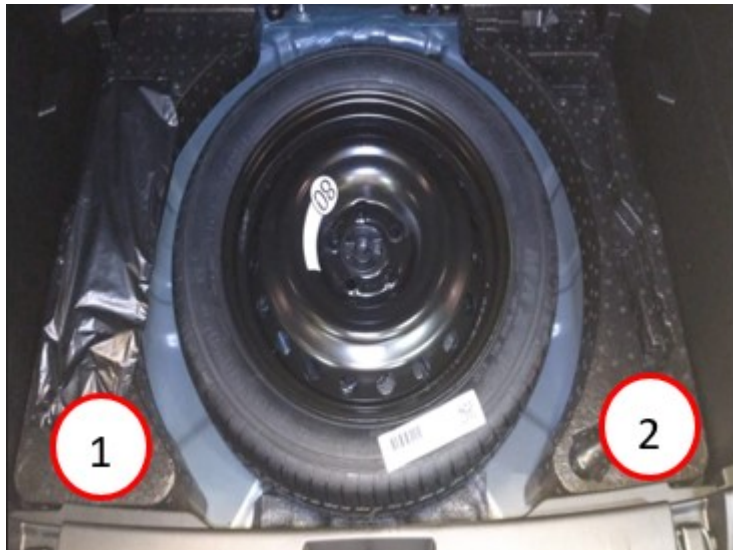
**Fig. 2**  
**Cargoboxes Installed**

- 1 - Left Cargo Box  
2 - Right Cargo Box

1. Open the rear hatch.
2. Lift up on the load floor.
3. Install the left and right cargoboxes (Fig. 2) .
