Technical Service Bulletin (TSB)  
Tail Lamp Assemblies Contacting Liftgate

<b>REFERENCE:</b>	<b>TSB:</b> 23-077-23 <b>GROUP</b> 23 - Body	<b>Date:</b>	June 27, 2023	<b>REVISION:</b>	-
<b>VEHICLES AFFECTED:</b>	<b>2023 (B1) Jeep Renegade</b> This bulletin applies to vehicles built on or after October 01, 2022 (MDH 1001XX) and on or before May 06, 2023 (MDH 0506XX).	<b>MARKET APPLICABILITY:</b>			
		<input checked="" type="checkbox"/> NA		<input type="checkbox"/> CH	
		<input type="checkbox"/> EE		<input type="checkbox"/> IAP	
		<input checked="" type="checkbox"/> SA		<input type="checkbox"/> MEA	
<b>CUSTOMER SYMPTOM:</b>	Tail lamp assemblies contacting liftgate creating a creaking noise.				
<b>CAUSE:</b>	Missing felt insulation.

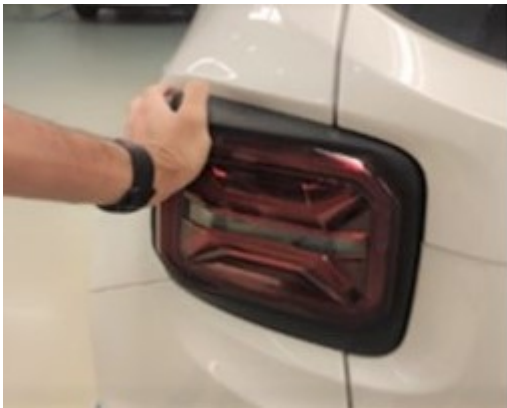
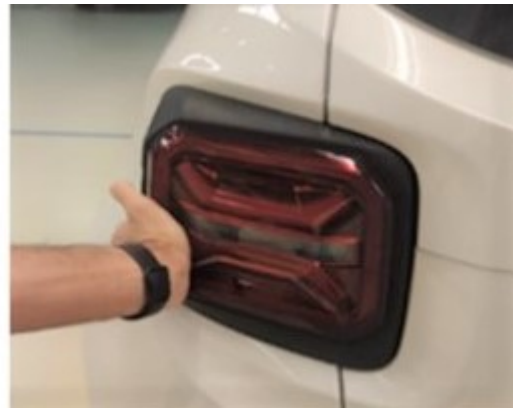
**Fig. 1**

1. With the liftgate in the closed position, push five times, on the outer and upper and lower corners of each tail lamp assembly using medium/moderate force towards the body (Fig. 1) .

**Outer Upper And Lower Corners Of Tail Lamp Assembly**

2. Was a creaking noise heard from one or both tail lamp assemblies (Fig. 1) ?
  - YES>>> Proceed to [Step 1](#) of the Repair Procedure.
  - NO>>> This bulletin has been completed. Use Inspect LOP (08-50-85-9G) to close the active RSU.

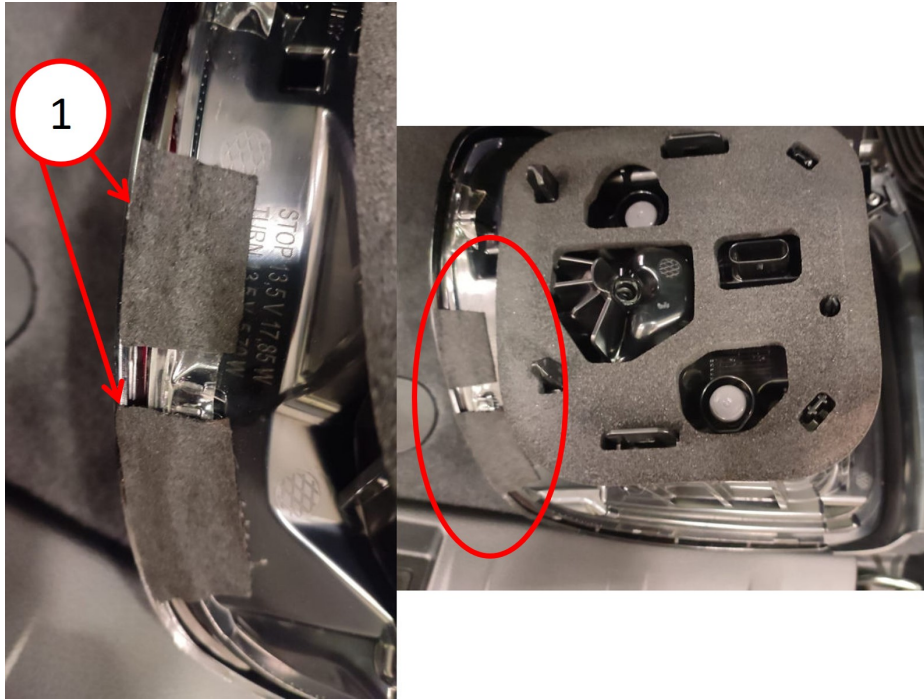
Fig. 2

**Areas To Apply Two Pieces Of Felt Insulation**

2. Apply two pieces of felt insulation to the side of the tail lamp assembly as required (Fig. 2) .

1 - Apply Two Pieces Of Felt Insulation Here (Second Pic Is For Reference)
