Technical Service Bulletin (TSB)
Intermittently Poor HVAC Performance

REFERENCE:	TSB: 23-080-23 GROUP 23 - Body	Date:	June 28, 2023	REVISION:	-
VEHICLES AFFECTED:	2019 - 2023 (DT) RAM 1500 Pickup This bulletin applies to vehicles built on or before December 12, 2022 (MDH 1212XX).	MARKET APPLICABILITY:			
		<input checked="" type="checkbox"/> NA <input type="checkbox"/> MEA <input type="checkbox"/> SA <input type="checkbox"/> IAP <input type="checkbox"/> EE <input type="checkbox"/> CH			
CUSTOMER SYMPTOM:	Customers may comment on the following: <ul style="list-style-type: none"> Intermittently the HVAC blow feel/output maybe reduced. This issue only happens in temperature that are just below freezing and snowing. 				
CAUSE:	Cowl Baffles.

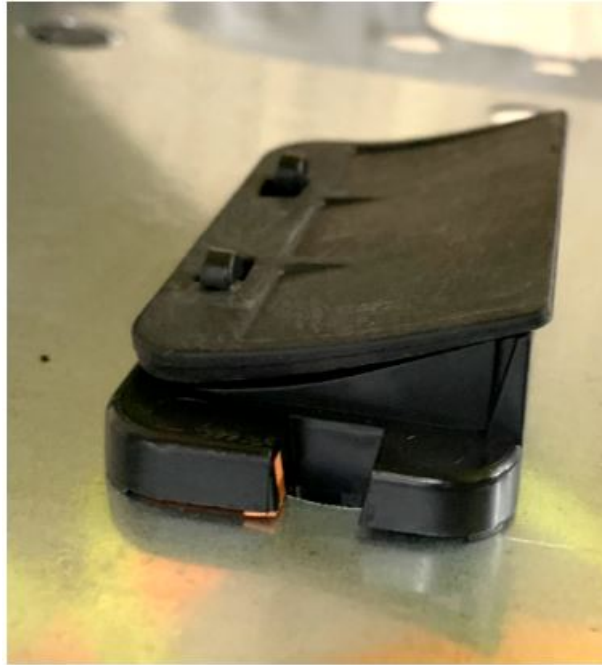
NOTE: There will be two hooks holding the flap to the baffle (**Fig. 1**) and (**Fig. 2**) .

Fig. 1
Baffle With Flap Installed

This bulletin involves removing the right side rubber flaps from the cowl baffles.

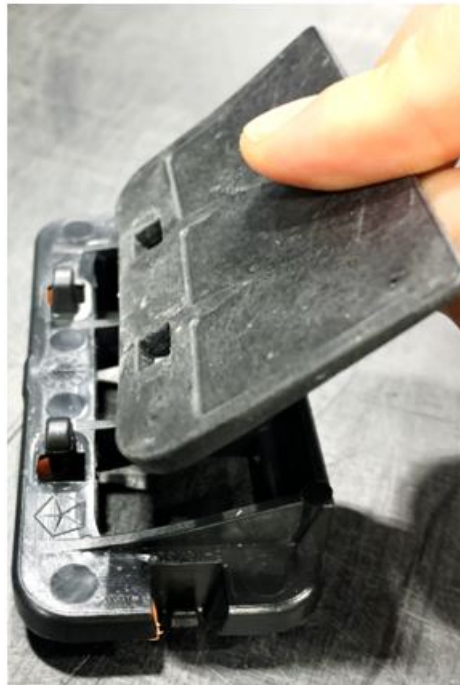
Fig. 2
Baffle With Flap Removed

3. After removing the flap from the baffle frame, discard the rubber flap (Fig. 2) .
4. Install the right front fender. Refer to the detailed service procedures available in DealerCONNECT/ Service Library under: Service Info> 23 - Body / Exterior / Fender, Front / Installation.

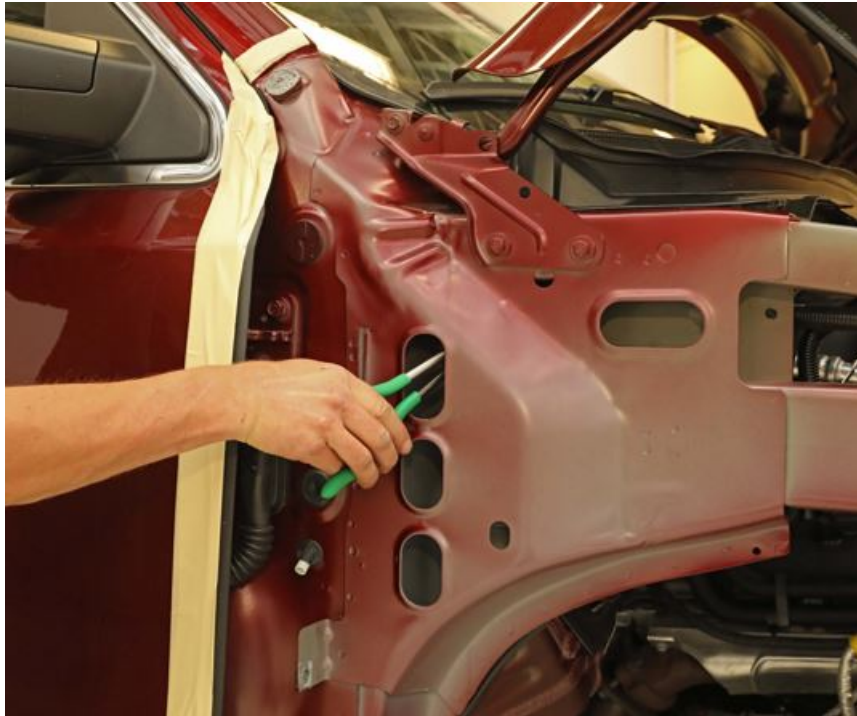
Fig. 3
Access Location to Baffle/Flap

2. Use a long pair of needle nose pliers, reach up into the access hole and remove the rubber flap off the baffle (Fig. 3) .
