<b>REFERENCE:</b>	<b>TSB:</b> 08-155-23 <b>GROUP</b> 08 - Electrical	<b>Date:</b>	June 29, 2023	<b>REVISION:</b>	-
<b>VEHICLES AFFECTED:</b>	2023 (DJ) RAM 2500 Pickup 2023 (D2) RAM 3500 Pickup 2023 (DP) RAM 4500/5500 Cab Chassis 2023 (DD) RAM 3500 Cab Chassis This bulletin applies to vehicles built on or after December 20, 2022 (MDH 1220XX) and on or before May 27, 2023 (MDH 0527XX) equipped with the Cluster 12" TFT Color Display (Sales Code JAN).	<b>MARKET APPLICABILITY:</b>			
<b>CUSTOMER SYMPTOM:</b>	The customer may experience one or more of the following: <ul style="list-style-type: none"> <li>Steering Wheel EVIC Switch used to Navigate Cluster Menu is Inoperative.</li> <li>No Illumination.</li> <li>No Response to button press.</li> </ul>				
<b>CAUSE:</b>	Power reset needed.

This bulletin involves performing a power reset to activate/awaken the EVIC buttons.

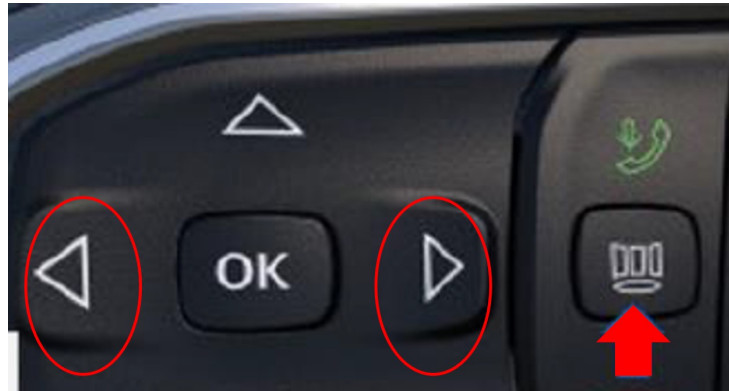
Fig. 1  
Arrow and Menu Buttons

1. Vehicle should be in customer mode.
2. Put Ignition into the RUN position, do not start.
3. Turn headlamp dimmer to full.
4. Using headlamp dimming wheel increase brightness so radio and cluster are visible.
5. On steering wheel LH switch, press menu button (Fig. 1) , verify the cluster home screen is shown (Fig. 2) .
6. At menu home. press RH/LH arrows and confirm the cluster responds and moves to different tiles (Fig. 1) .
7. Vehicles that do not have a response to a menu button press or arrow press (Fig. 1) . Proceed to [Step 1](#) of the Repair Procedure.
