REFERENCE:	TSB: 08-157-23 GROUP 08 - Electrical	Date:	June 29, 2023	REVISION:	—
VEHICLES AFFECTED:	2021 (WL) Jeep Grand Cherokee This bulletin applies to vehicles equipped with: <ul style="list-style-type: none"> • Uconnect 5 NAV W 10.0" Display (Sales Codes UBN or UEN). • Uconnect 5 NAV W 8.4" Display (Sales Codes UBL or UEL). • Uconnect 5 W 8.4" Display (Sales Codes UBF or UEF). 			MARKET APPLICABILITY: <input checked="" type="checkbox"/> NA <input type="checkbox"/> MEA <input type="checkbox"/> SA <input type="checkbox"/> IAP <input type="checkbox"/> EE <input type="checkbox"/> CH	
CUSTOMER SYMPTOM:	<ul style="list-style-type: none"> • Amplifier module sets Diagnostic Trouble Code (DTC) U0485 - Implausible Data Received Set. • Radio reset (Rearview camera functions normally). • Voice Recognition (VR) inoperable. • Wireless CarPlay® inoperable. • Audio sources inoperable. • Display switches to Nav on VR prompt. • Compass inoperable, does not update direction. • Vehicle Positioning (Lat/Long) inoperable. • Surround View Camera inoperable (Rearview camera functions normally). • Unable to exit FamCam. • Audio Repetition inoperable. • Electric vehicle pages inoperable. • Translated te

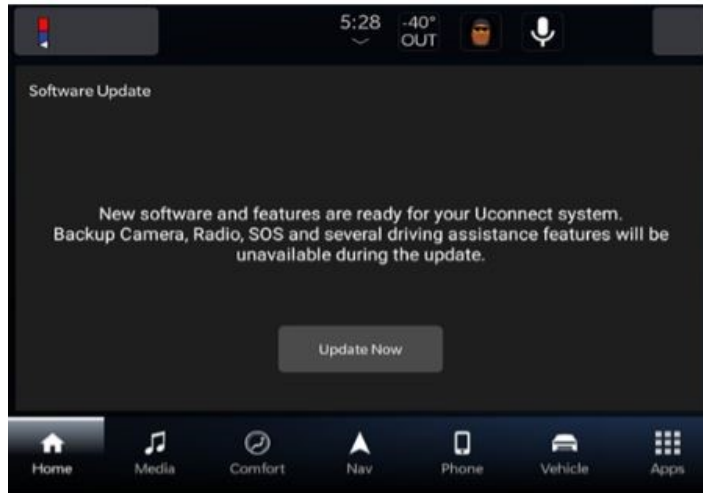
Fig. 1
Software Acceptance Screen

Customers will see a notification on their radio screen when new software is available for their radio (Fig. 1) . The owner will have the option to update the radio or schedule the update for later. There is not an option to decline the update indefinitely, the update must be performed.

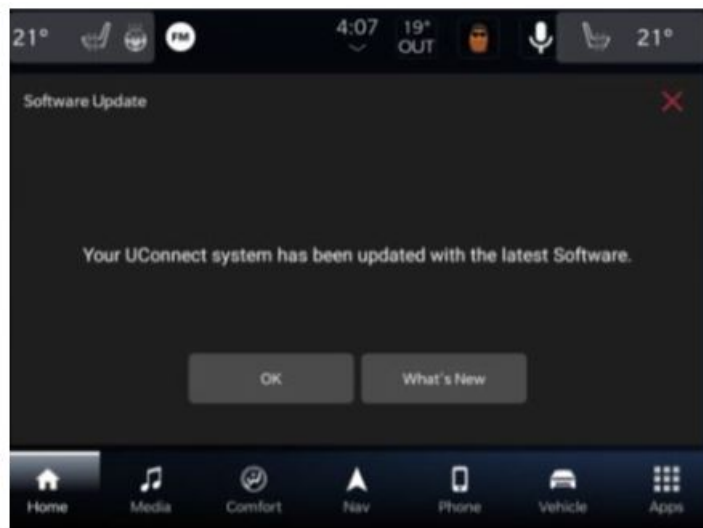
Fig. 2
Software Update Confirmation Screen

3. Upon completion of update, the radio will display a confirmation message (Fig. 2) .
