REFERENCE:	TSB: 08-156-23 GROUP 08 - Electrical	Date:	June 29, 2023	REVISION:	—
VEHICLES AFFECTED:	2023 (WD) Dodge Durango 2023 (RU) Chrysler Pacifica This bulletin applies to: <ul style="list-style-type: none"> • RU vehicles built on and before June 04, 2023 (MDH 0604XX). • WD vehicles built on and before June 15, 2023 (MDH 0615XX). Equipped with Global Telematics Box Module (Sales Code RDG).			MARKET APPLICABILITY:	
				<input checked="" type="checkbox"/> NA	<input type="checkbox"/> MEA
				<input type="checkbox"/> SA	<input type="checkbox"/> IAP
				<input type="checkbox"/> EE	<input type="checkbox"/> CH
CUSTOMER SYMPTOM:	Customers may experience one or more of the following: <ul style="list-style-type: none"> • Uconnect Box requires service message at start up. • Losing WiFi Hotspot streaming connection: internet data is not reliable. • User is unable to setup the Charge schedule/Climate schedule events in Uconnect App (TBM is sending failure message). • LED blinking on overhead console after ignition cycle.

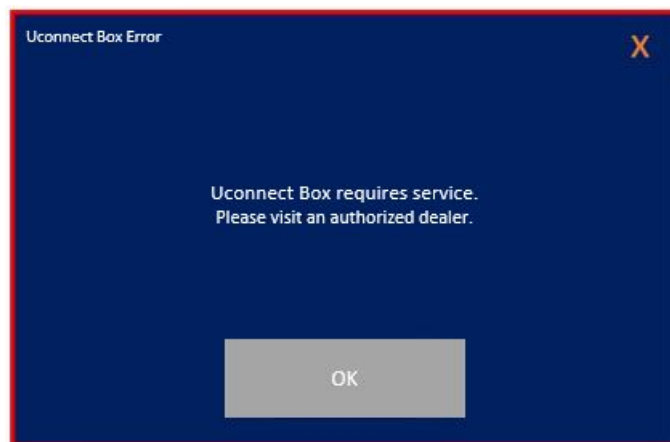
Fig. 1
Uconnect Box Error Message

CAUSE:	TBM Software

Message display on the radio screen, “Uconnect Box requires service. Please visit an authorized dealer.” (Fig. 1) , with no active or stored Diagnostic Trouble Codes (DTCs) set by the TBM.

This bulletin provides information regarding the latest Firmware Over The Air (FOTA) update and provides the service technician an overview of the steps a customer will need to take to complete the update. The TBM software will be updated from 4.27i (WD) and 4.29d (RU) to 4.36.
