REFERENCE:	TSB: 08-160-23 GROUP 08 - Electrical	Date:	June 30, 2023	REVISION:	08-039-22 REV. C						
VEHICLES AFFECTED:	<p>2022 (WL) Jeep Grand Cherokee 2022 (WS) Grand Wagoneer/Wagoneer This bulletin applies to vehicles equipped with one of the following radios:</p> <ul style="list-style-type: none"> • Uconnect 5 NAV W 12" Display (Sales Codes UFQ, UBQ, UEQ). • Uconnect 5 NAV W 10.1" Display (Sales Codes UFN, UBN, UEN). • Uconnect 5 W 8.4" Display (Sales Codes UFF, UEF, UBF). • Uconnect 5 Nav W 8.4" Display (Sales Codes UFL, UBL, UEL). 			<p>MARKET APPLICABILITY:</p>

This bulletin involves inspecting the software level and updating the software to ****T25.50.****

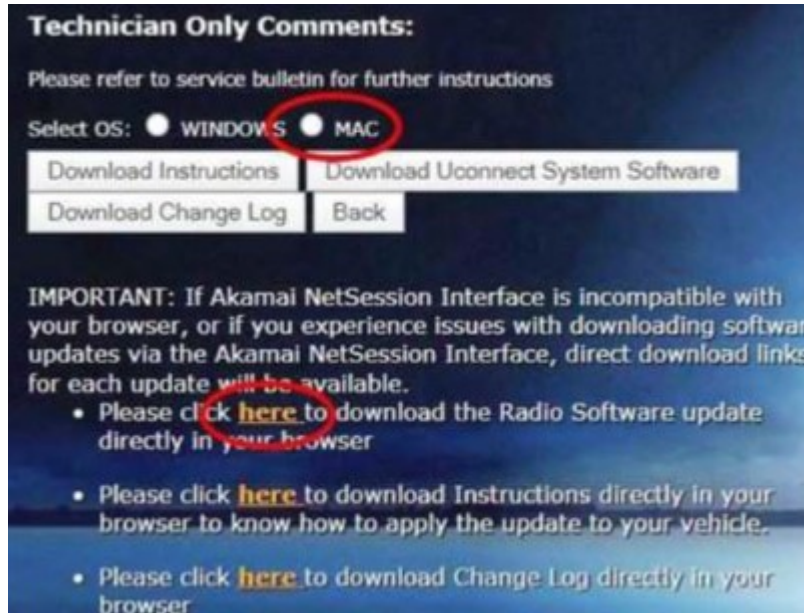
Fig. 1

MAC Download Steps

6. Download the software update file to your local PC's desktop. Make sure to select the "MAC" radial button for all downloads (Fig. 1) .

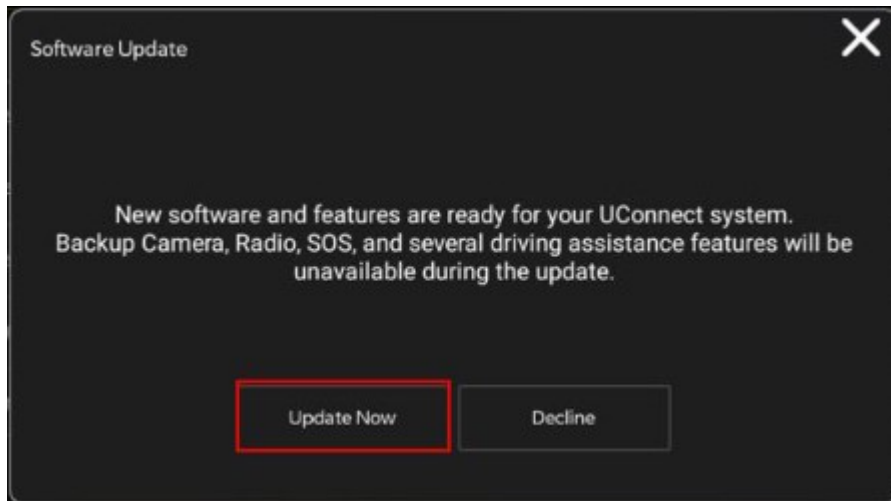
Fig. 2
Software Update Is Available

12. Once the system has verified there is an available update, press the “Update Now” button. Make sure the vehicle is in park. **Do NOT turn the ignition off until the two minute timer has expired. The ignition doesn’t have to be turned off to update the radio’s software (Fig. 2) .**

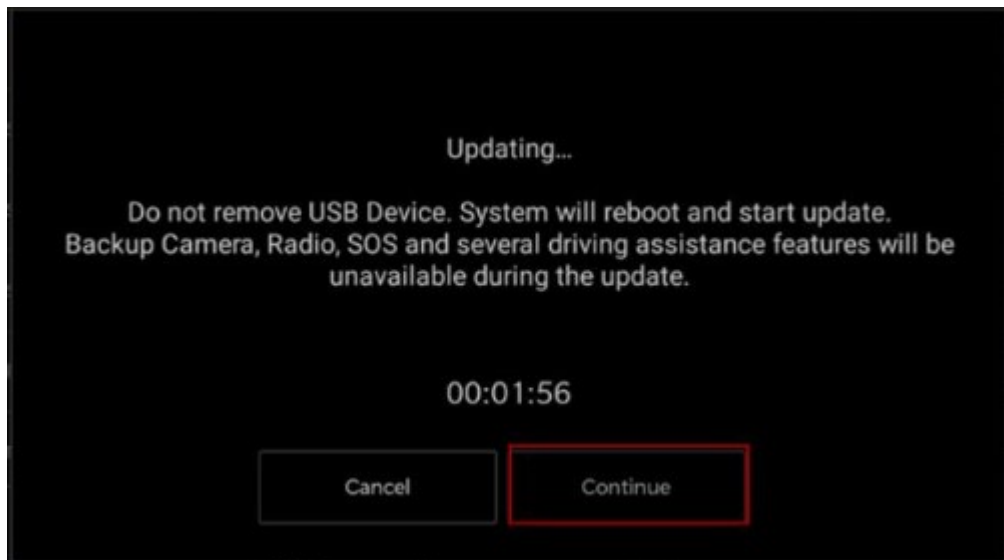
Fig. 3
Continue Display Screen

13. Press the “Continue” on the display screen (Fig. 3) .

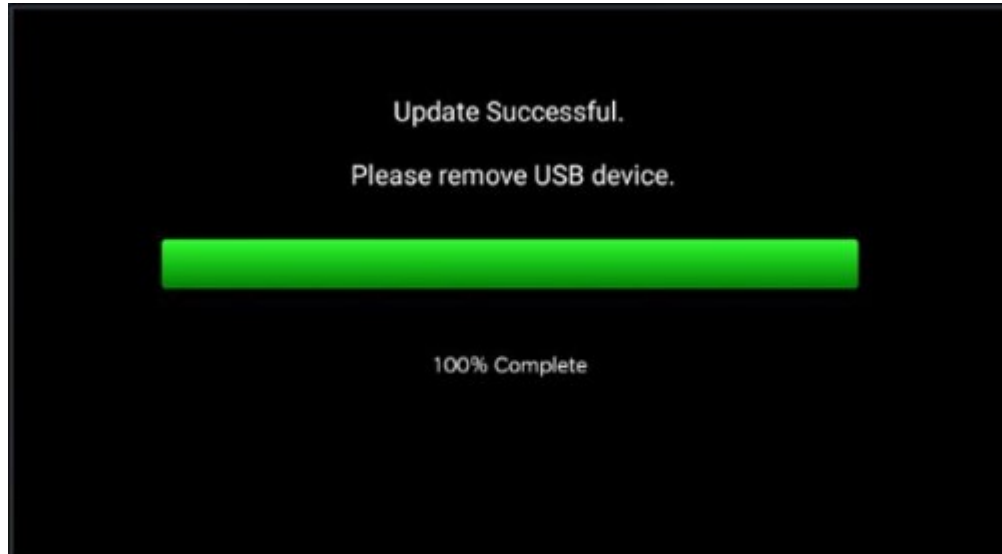
Fig. 4
Software Update Completed

14. The radio will reboot and the update will begin. The update should only take 30 minutes (Fig. 4) .

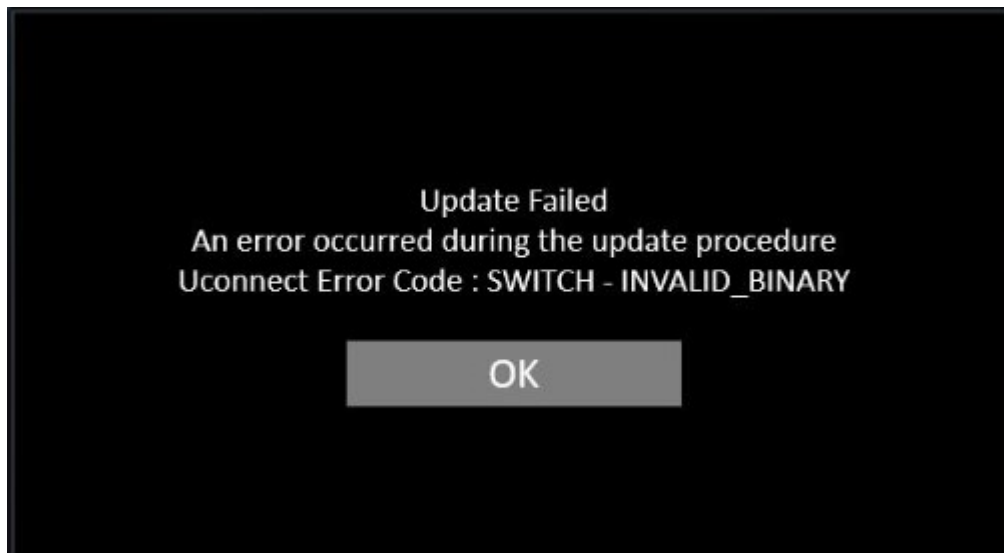
Fig. 5
Error Message

15. **Do Not** turn off the ignition at this point. The update is still in process, wait until the radio restarts and the home screen is displayed. This should take around five minutes
16. Sometimes the radio will display an error pop up " SWITCH - INVALID_BINARY" after successful radio update. Please ignore this error message and press "OK" to continue (Fig. 5) .

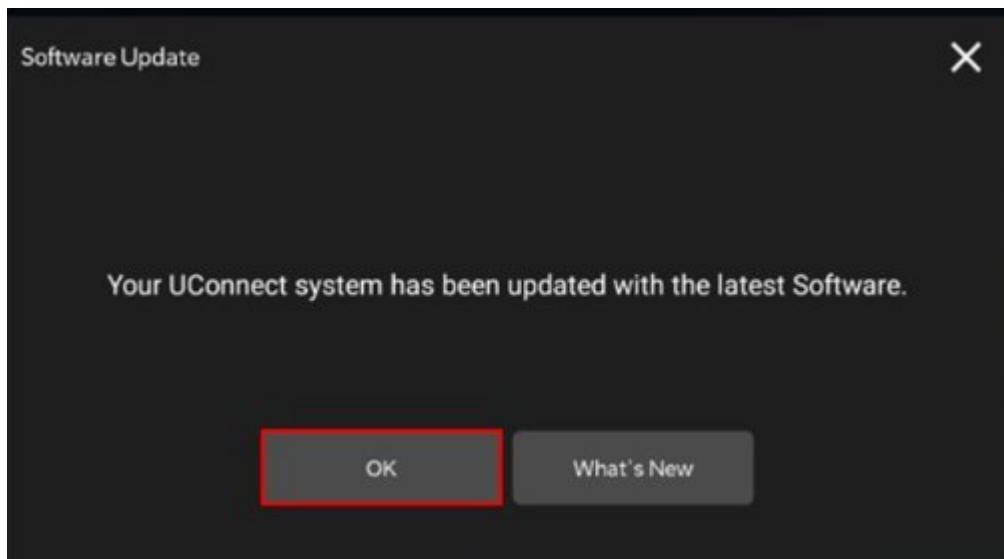
Fig. 6
Radio Software Has Been Updated

17. Press “OK” to continue (Fig. 6) .
