## Technical Service Bulletin (TSB)

### Flash: Electric Power Steering (EPS) Module Updates

| REFERENCE: | TSB: 08-149-23 REV. A<br>GROUP 08 - Electrical | Date: | June 23, 2023 | REVISION: | 08-149-23 |
| VEHICLES AFFECTED: | 2023 (GC) Alfa Romeo Tonale<br>This bulletin applies to vehicles built on or before May 30, 2023 (MDH 0530XX). | | | MARKET APPLICABILITY:<br><input checked="" type="checkbox"/> NA <input type="checkbox"/> MEA<br><input type="checkbox"/> SA <input type="checkbox"/> IAP<br><input type="checkbox"/> EE <input type="checkbox"/> CH | |

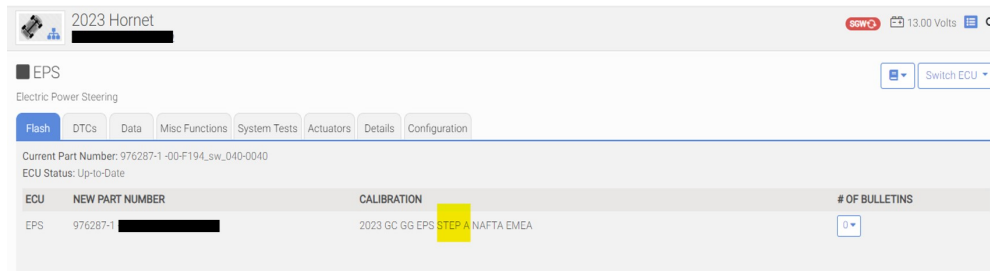
**Fig. 1**  
**Example of wiTECH Step Flashes**

**CAUTION! \*\*Multiple step flashes up to three may be necessary and are required to completely update this EPS these must be performed in order starting with STEP A or B and ending with Step C, be sure to follow wiTECH accordingly (Fig. 1) .\*\***

3. **\*\*Select the appropriate software per wiTECH (Step A, B or C) either Step A or B must be done first in order and end with Step C when finished.\*\***
4. Reprogram the EPS module with the latest software. Detailed instructions for flashing control modules using the wiTECH Diagnostic Application are available by selecting the application's "HELP" tab.
5. Wait 2 minutes after the EPS flash has been completed.
6. To perform an EPS reset with wiTECH - Go to the Guided Diagnostics menu --> Select Reset ECU --> Select "EPS" from the list of modules --> Click "Continue" at the bottom of the page then follow the wiTECH prompts.
