Subject: N232409000 - Service Update
Engine Wiring Harness Chafe

Models: 2023 Chevrolet Colorado
2023 GMC Canyon

Service Update

N232409000 Engine Wiring Harness Chafe

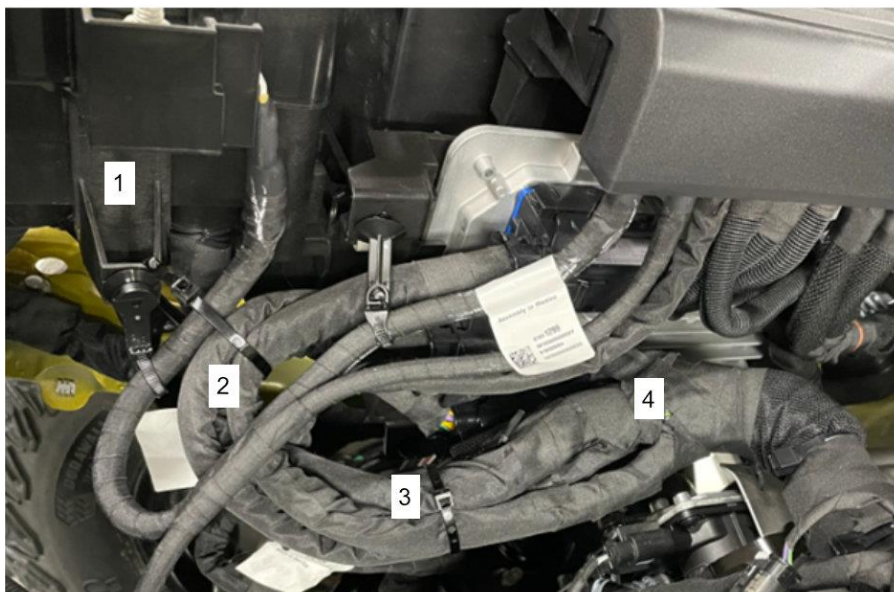
6408262

Condition	Certain 2023 model year Chevrolet Colorado and GMC Canyon vehicles may have a condition where there is insufficient clearance between the wiring harness and the turbo actuator.
Correction	Dealers are to install cable ties to the engine wiring harness.

2. Find the mounting extension on the fuse block bracket (1).

3. Use the first cable tie (2) to loop around the three ECM wiring leads and the mounting extension on the fuse block bracket.
 - a. Tighten and trim excess cable tie.
4. Follow the three ECM wiring leads to their intersection with the main engine harness (4)
5. Use the second cable tie (3) to loop around the 3 ECM wiring leads and the main engine harness, at approximately 100mm from the point where the leads meet the main engine harness.
 - a. Tighten and trim excess cable tie.
6. Install air cleaner outlet duct. Refer to *Air Cleaner Outlet Duct Replacement* in SI.
