Subject: N232398360 - Customer Satisfaction Program  
Loss of OnStar Audio

Models: 2016 Buick Envision

# Customer Satisfaction Program

## N232398360 Loss of OnStar Audio

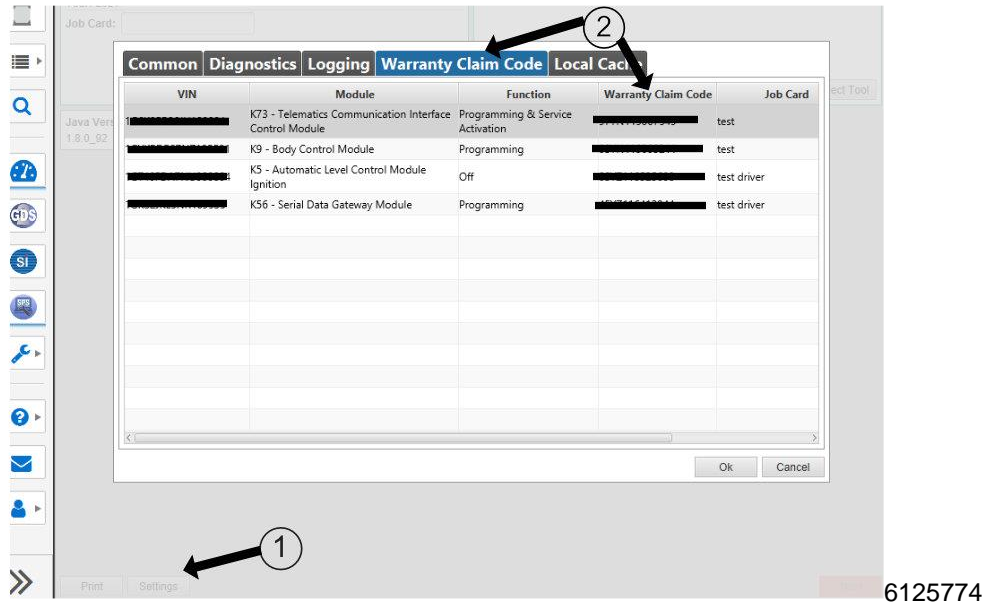
6125814

1. Open TLC on the computer used to program the vehicle.
2. Select and start SPS2.
3. Select Settings (1).
4. Select the Warranty Claim Code tab (2).

The VIN, Warranty Claim Code and Date/Time will be listed on a roster of recent programming events. If the code is retrievable, dealers should resubmit the transaction making sure to include the code in the SPS Warranty Claim Code field.

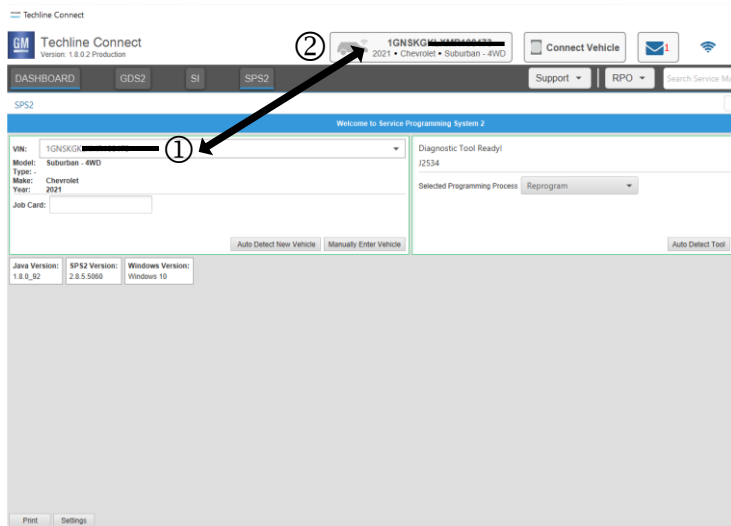
5743643

**Caution:** Be sure the VIN selected in the drop down menu (1) is the same as the vehicle connected (2) before beginning programming.

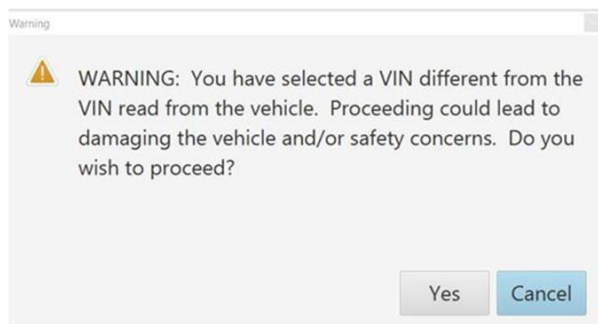
5877000

**Important:** If the vehicle VIN DOES NOT match, the message below will be shown.

- If the VIN that shows up in the TLC top center window after correctly reading the VIN from the vehicle does not match the VIN plate of the vehicle, manually type in the VIN characters from the vehicle VIN plate into the TLC top center window and use these for programming or reprogramming the subject module with the correct vehicle VIN and software and/or calibrations.

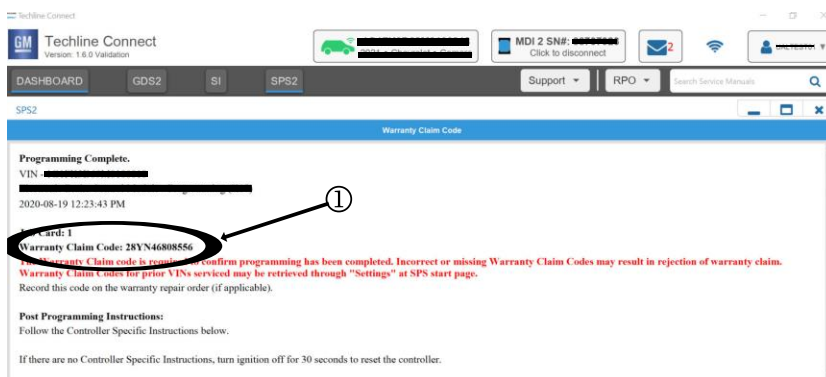
5644478

**Important:** To avoid warranty transaction rejections, you **MUST** record the warranty claim code provided on the Warranty Claim Code (WCC) screen shown above on the job card. Refer to callout 1 above for the location of the WCC on the screen.

2. Record SPS Warranty Claim Code on job card for warranty transaction submission.
