# Service Action

## Code: 34K1

**About this Service Action:** Volkswagen is providing updated transmission control module (TCM) software to enhance an in-vehicle alert should a problem arise within the auxiliary hydraulic pump. Additionally, if a specific fault is found after the software is updated, a repair will be made to the transmission.

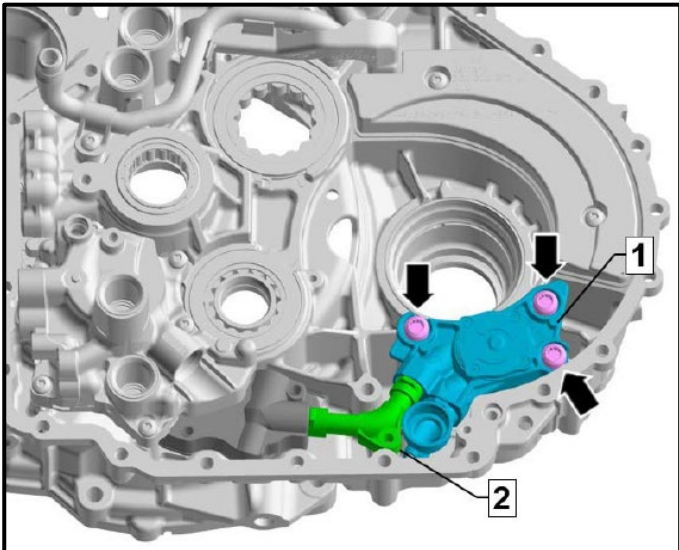
### Remove auxiliary hydraulic pump:

- Remove bolts <arrows>.
- Carefully detach auxiliary hydraulic pump <1> upwards and pull it out of oil pipe <2>.
