Service Update

N222384940 Air Compressor Port Mis-Build

Release Date: August 2023

Models: 2022 Chevrolet Silverado 4500HD/5500HD/6500HD
Equipped with AIR COMPRESSOR-ACCESSORY DRIVE (RPO KUT)

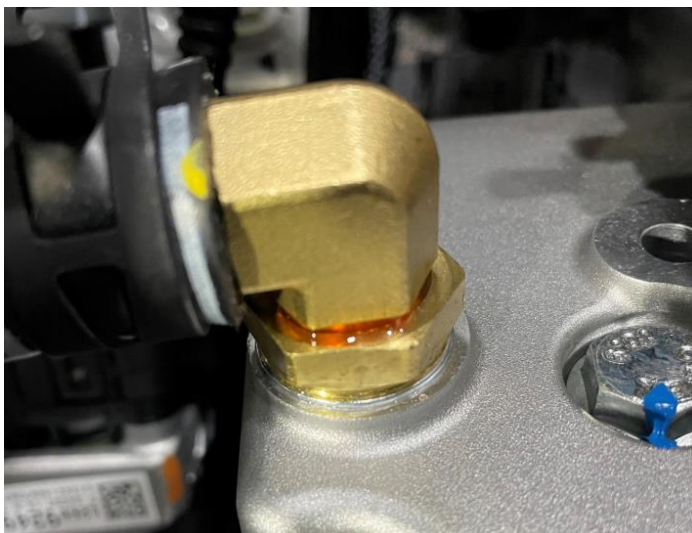
6405853

Condition	On certain 2022 model year Chevrolet Silverado 4500HD/5500HD/6500HD vehicles, the air compressor coolant outlet port may cause a slow coolant leak at the air compressor on the engine.
Correction	Dealers are to inspect, and if necessary, replace the automatic level control air compressor.

1. Inspect the Automatic Level Control Air Compressor to see if the Coolant Outlet Port has a leak as shown.
 - If the Coolant Outlet Port is not leaking, no further action is required.
 - If the Coolant Outlet Port is leaking, proceed to step 2.
2. Replace the Automatic Level Control Air Compressor. Refer to *Automatic Level Control Air Compressor Replacement* in SI.
