Release Date	08/03/2023	Technical Service Bulletin		
<b>42M6 UPDATE</b>

<b>Rear Suspension Adjustment Bolts – (NVLW)</b>

This Update has been proactively released to prevent the following condition(s) from occurring in the vehicle:	
Criteria	Technical Background
01	Rear suspension bolts may not have been properly torqued. Rear suspension bolts that are not correctly tightened may cause the alignment angles of the rear suspension to change over time. If this occurs, this can lead to pre-mature tire wear.

Criteria	Remedy
01	Check the rear axle alignment and torque of the rear suspension adjustment bolts. If the any of the bolts are not at the correct torque, the rear axle alignment will be corrected as needed and the adjustment bolts torqued to the proper specification. The tires will be checked for premature and uneven wear. If found, the tires will be replaced as necessary.

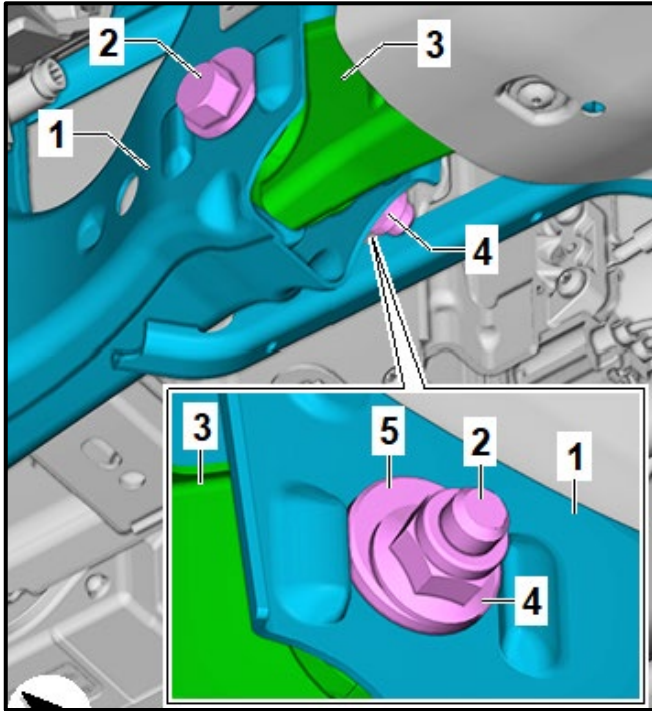
- Check the torque of the driver and passenger rear camber adjustment nuts <4> while counter holding the bolt <2>.
  - Torque specification: 190 Nm

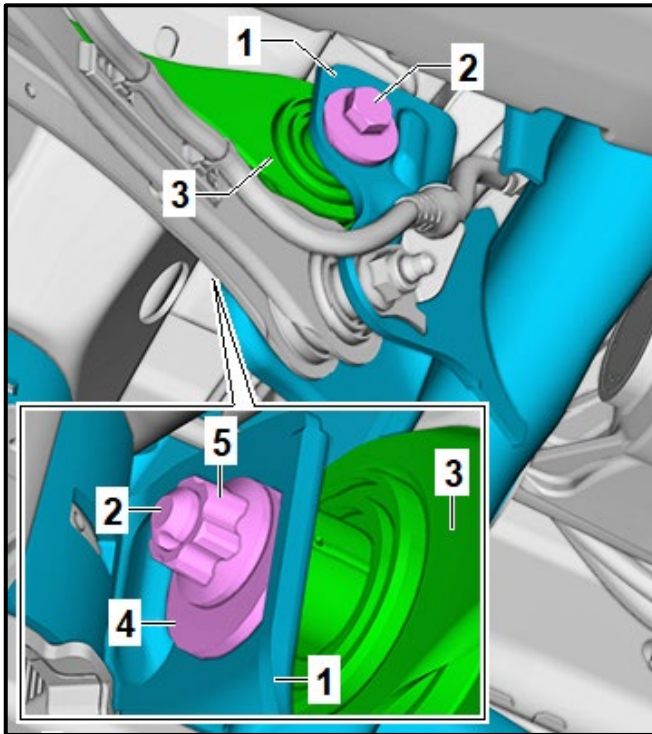
- Check the torque of the driver and passenger rear toe adjustment nuts <5> while counter holding the bolt <2>.
  - Torque specification: 95 Nm

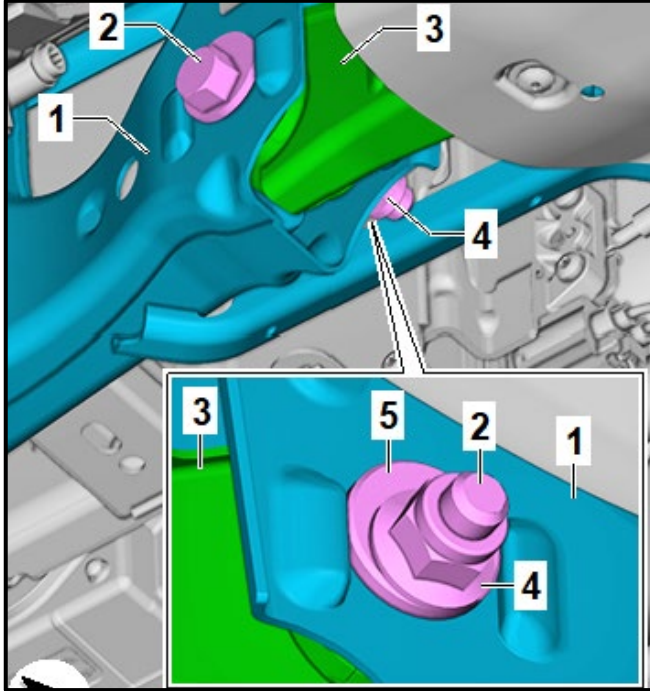
- If the camber adjustment nut(s) is at the incorrect torque, replace the nut(s) <4>.

- Adjust camber back to the original measurement.
- Counter hold the bolt <2> and tighten the nut <4> to 190 Nm.

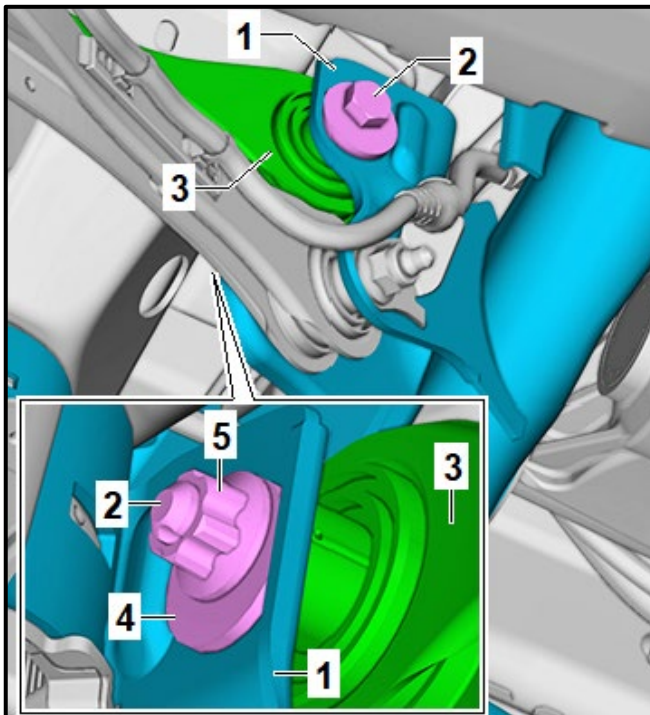
- If the toe adjustment nut(s) is at the incorrect torque, replace the nut(s) <5>.

- Adjust toe back to the original measurement.
- Counter hold the bolt <2> and tighten the nut <5> to 95 Nm.

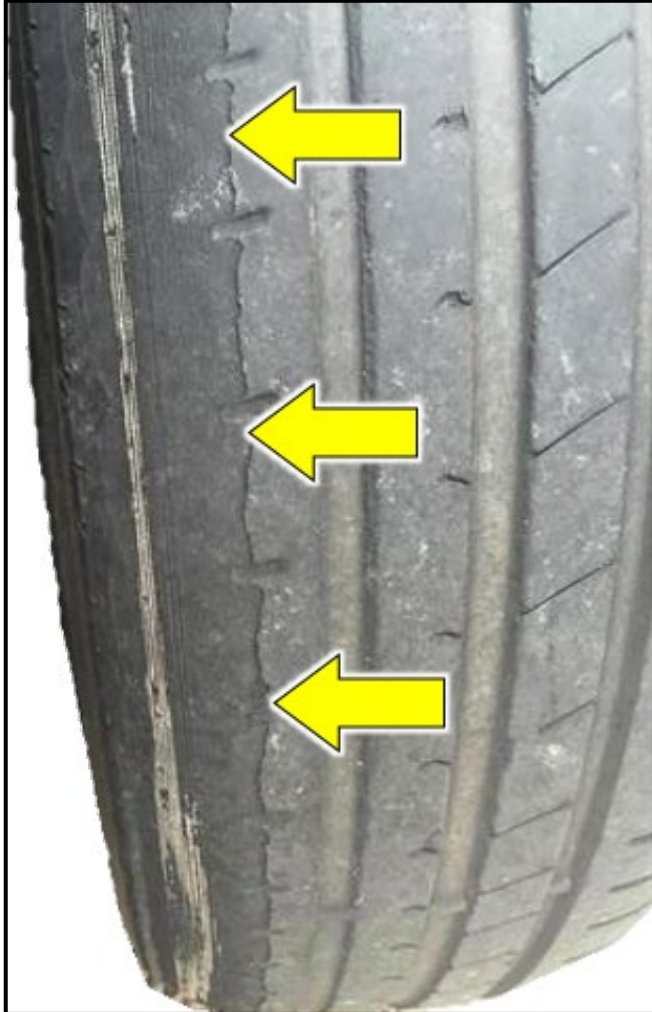
- Check the rear tires for uneven wear.
  - Example of uneven wear shown <arrows>.
- If uneven wear is noted, replace the affected rear tire(s).
- If the difference in wear between the new rear tire and the remaining rear tire is greater than 1mm, the remaining rear tire must be replaced.
- If the difference in wear between the front tires and the new rear tires is greater than 2mm, both front tires must also be replaced.
- If any tires are to be replaced:
  - Take clear photos of the uneven tire wear.
  - U.S. dealers: Create a WISE Campaign Authorization request and attach photos for review.
  - Canadian dealers: Create a TAC WEB ticket with photos attached for review.

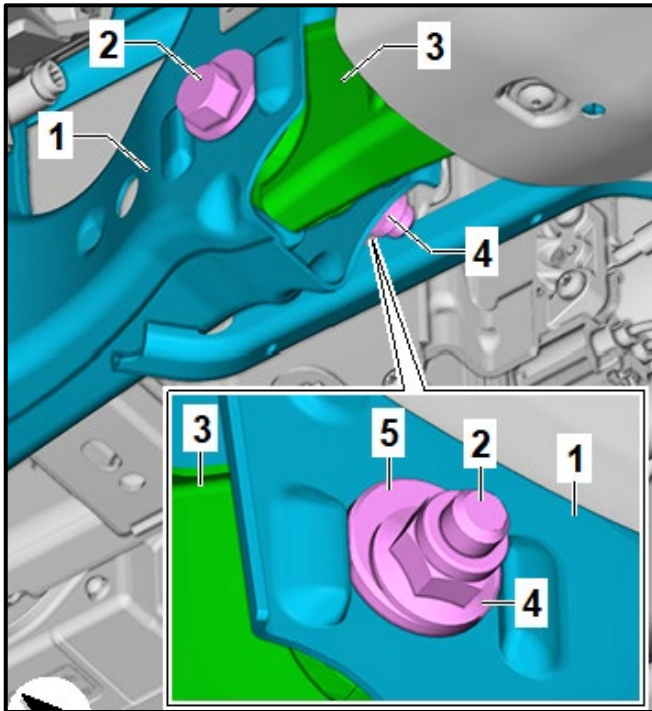
- If the camber adjustment nut(s) is at the incorrect torque, replace the nut(s) <4>.

- Adjust the rear camber as required per the wheel alignment program and the ELSA repair manual:
  - *Repair manual > Chassis > Suspension, Wheels, Steering > 44 Wheels, Tires, Wheel Alignment > Axle alignment > Rear Axle Camber, Adjusting*
- Counter hold the bolt <2> and tighten the nut <4> to 190 Nm.

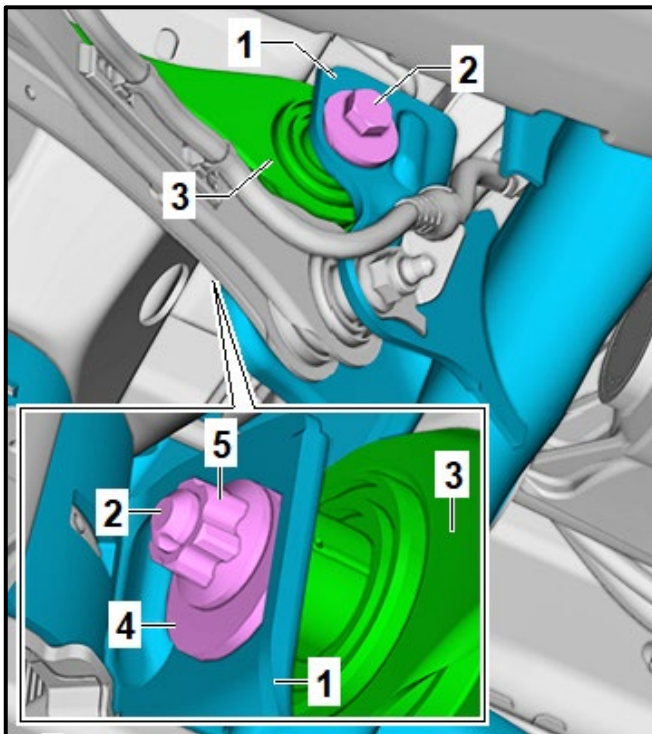
- If the toe adjustment nut(s) is at the incorrect torque, replace the nut(s) <5>.

- Adjust the rear toe as required per the wheel alignment program and the ELSA repair manual:
  - *Repair manual > Chassis > Suspension, Wheels, Steering > 44 Wheels, Tires, Wheel Alignment > Axle alignment > Rear Axle Toe, Adjusting*
- Counter hold the bolt <2> and tighten the nut <5> to 95 Nm.
