Technical Service Bulletin

01 MIL on P045600 Very Small Leak Detected - NVLD

01 23 66 2071199/1 August 9, 2023.

Model(s)	Year	VIN Range	Vehicle-Specific Equipment
A4, A4 allroad, S4, A5, A5 Cabriolet, A5 Sportback, S5, S5 Cabriolet, S5 Sportback, RS 5, and RS 5 Sportback	2021 – 2023	All	Not Applicable

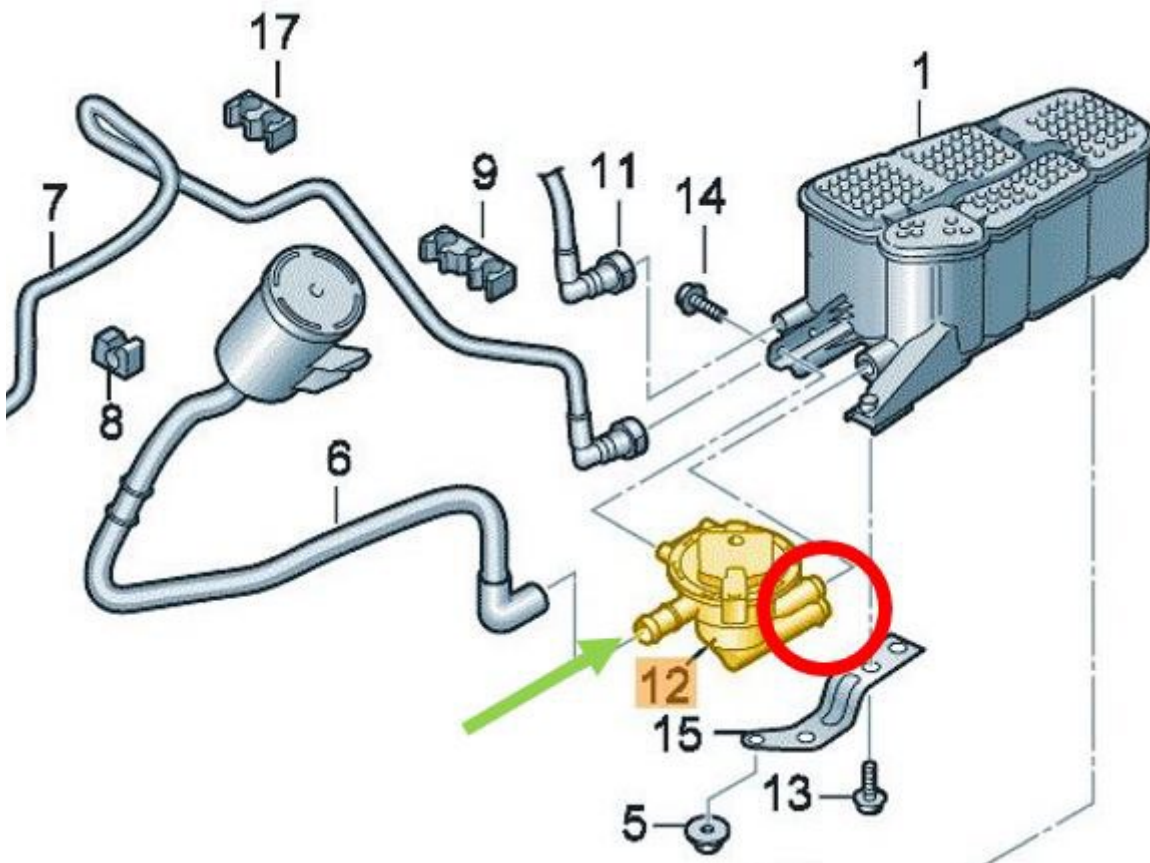
The smallest contamination may be sufficient to cause an internal leak in fuel tank pressure sender G400 (NVLD); this can lead to the DTC “P045600 – Very Small Leak Detected” being set.

Figure 1: Fuel tank pressure sender G400 (NVLD).

- Using a compressed air gun, please blow through the NVLD (item 12 in illustration) with several brief pressure applications of approx. 5 bar. To do so, use the opening on the NVLD marked in the illustration by a green arrow (figure 1).

The opening marked with a red circle (figure 1) must not be closed or exposed to compressed air, as this may cause irreparable damage to the NVLD. In addition, this ensures that possible contamination can be blown out of the NVLD.

While blowing through the component as described, please hold it in your hand -> the component must not be clamped or secured in a vice (risk of damage).

Reinstall the fuel tank pressure sender G400 (NVLD), and recheck the system for leaks.
