Technical Service Bulletin

01 MIL on, DTC P040100 is stored in the ECM - TDI

01 23 68 2064398/3 August 11, 2023. Supersedes Technical Service Bulletin Group 01 number 23-63 dated July 25, 2023 for reasons listed below.

Model(s)	Year	VIN Range	Vehicle-Specific Equipment
A3 TDI	2010 – 2013	All	Not Applicable

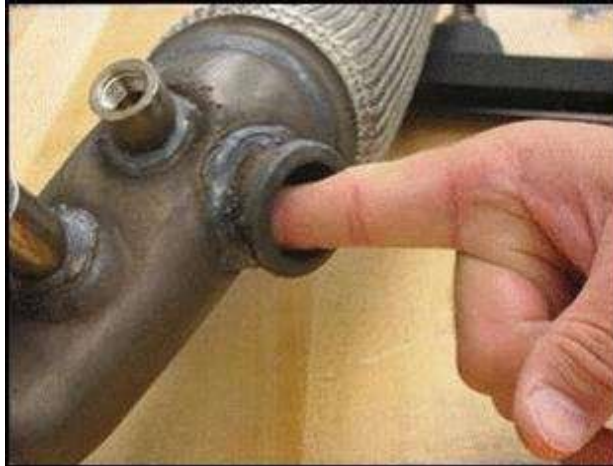
Figure 1. Checking for carbon.

1. Remove the EGR filter from the Diesel Particulate Filter (DPF) and swipe the inside of the exhaust pipe at the EGR filter connection point using a clean cloth or your finger.

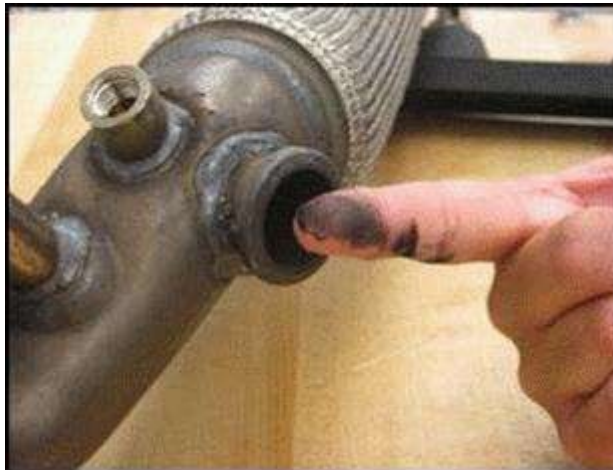
Figure 2. Verifying that there is carbon.

2. If your finger or the cloth comes out with black soot:
 - Replace the DPF & EGR filter together. **The engine must be running correctly with no faults stored to perform the next steps.**
 - Read out 01 ECM control module OBD Basic Settings block 67 with engine at idle and at operating temperature. Select activate and monitor field 3 when EGR is in OFF position.
 - If the MAF actual value is equal to or greater than 540 mg/h, proceed to smoke testing below (there is likely a leak within the intake system).
 - If the value is less than 540 mg/h, proceed to the inspection of the snow flap and air filter (TSB attachment). There is no need to smoke test.
 - Smoke test the charge air system for leaks if MAF value is 540 or great (see procedure below).

When replacing the DPF for the fault **P0401**, **P2002**, or **P240F** it is important to replace both the DPF and the EGR filter together, as soot accumulation in the EGR filter is undesired. It is NOT necessary to replace any other components for this fault (i.e. NOx Storage Catalyst, Sulfur Catalyst, Exhaust Flap, EGR Cooler). These components should be reinstalled in the vehicle with the new DPF and EGR filter. If the particulate filter was replaced, an adaptation must be performed in Guided Functions.
