Technical Service Bulletin

87 Air conditioning does not cool, DTC B16A284 is stored in the thermal management control module
87 23 53 2061660/2 August 24, 2023. Supersedes Technical Service Bulletin Group 87 number 20-12 dated December 15, 2020 for reasons listed below.

Model(s)	Year	VIN Range	Vehicle-Specific Equipment
A8, A8 e quattro, and S8	2020 – 2021	All	Not Applicable

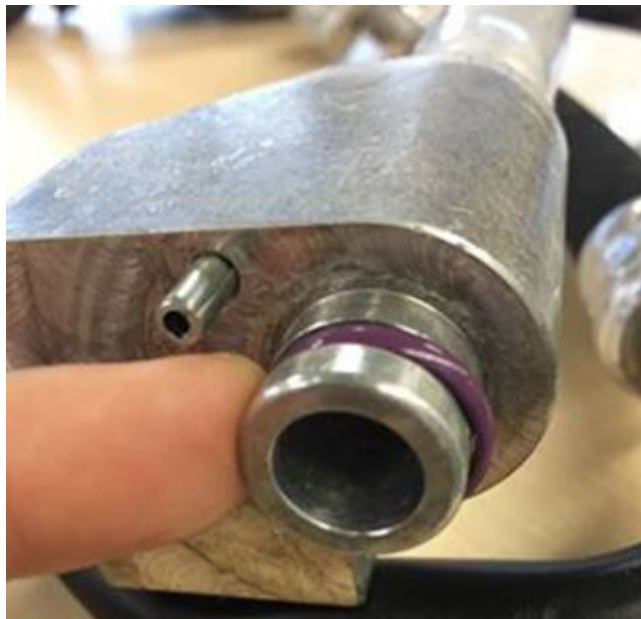
A refrigerant leak test reveals a leak at the bolted connections of the refrigerant line with inner heat exchanger that connects the main circuit to the rear evaporator. When the line is removed an incorrect and/or damaged O-ring seal is found (Figure 1).

Figure 1. Damaged refrigerant line O-ring seal.

1. Perform an air conditioning circuit leak test diagnosis using either contrast dye or by pressurizing the circuit with compressed nitrogen and investigating the leak location with a soapy water solution at each end of this refrigerant line. Provided no damage to the mating sections of the line are found replace the O-ring seals on either end of the line. If a leak is not found at either end of this refrigerant line, continue with the leak diagnosis and repair.
2. Please take photos of the customer concern and upload them into DOC-IT with the repair order. Photos should:
 - Have a date stamp and VIN reference.
 - Be taken in focus and with sufficient light.
 - Where it is appropriate, mark the affected place for a reference to the concern for analysis.

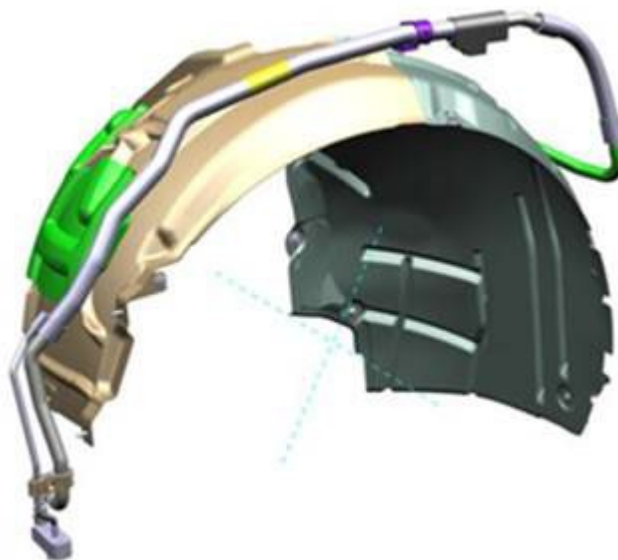
The refrigerant line with inner heat exchanger is located inside the left front wheel housing liner (Figure 2).

Figure 2. Location of the refrigerant line with inner heat exchanger that connects the main refrigerant circuit to the rear evaporator
