Technical Service Bulletin

90 Instrument cluster: various malfunction LEDs are lit sporadically without DTCs stored in any modules
90 23 37 2064789/4 August 24, 2023. Supersedes Technical Service Bulletin Group 90 number 23-19 dated March 23, 2023, for reasons listed below.

Model(s)	Year	VIN Range	Vehicle-Specific Equipment
A4, A4 allroad, S4, A5, A5 Cabriolet, A5 Sportback, S5, S5 Cabriolet, and S5 Sportback	2020 – 2023	All	Not Applicable
RS5, and RS 5 Sportback	2021 – 2023

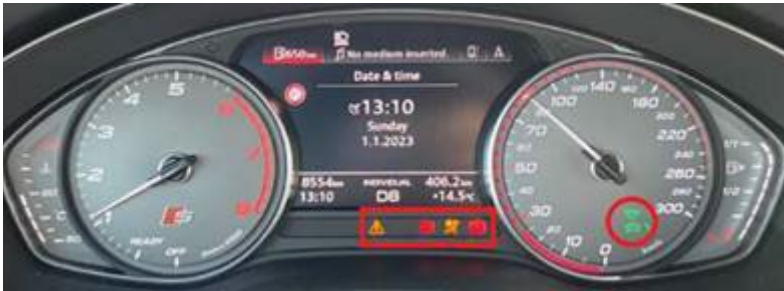
Due to a deviation in the current draw of the LEDs for the adaptive cruise control lamp, the warning lamps shown in figure 1 may unintentionally illuminate.

Various warning lamps may be illuminated (Figure 1); in this case, **NO DTCs** will be stored.

Figure 1: The warning lamps illuminated in the red rectangle are unintentional.

If the customer concern match as stated above, update Instrument cluster J285 (address word 0017) using SVM code **17A047**. Please reference the TSB number in the claim comments.
