Technical Service Bulletin

55 Paint abrasions on rear lid from tail lamps

55 23 78 2071125/1 August 4, 2023.

Model(s)	Year	VIN Range	Vehicle-Specific Equipment
Q4 e-tron, and Q4 e-tron quattro	2022 – 2023	All	Not Applicable

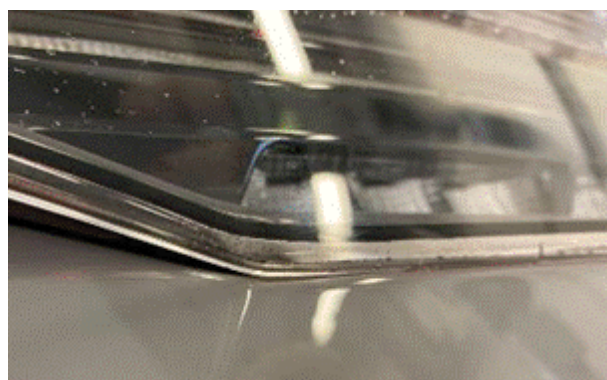
Workshop findings: The gap between the tail lamp and the rear lid is too small or non-existent causing contact to the rear lid and damaging the painted surface. In some cases the corrosion protection is also compromised and corrosion in the rear lid could be visually apparent.

Figure 1 shows a tail lamp to rear lid gap that is insufficient.

Figure 1. Rear lid tail lamp with an insufficient gap to the rear lid.

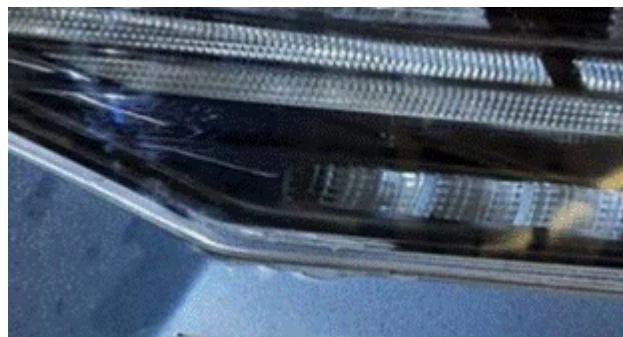
Insufficient clearance between the rear tail lamp and the rear lid creates contact between the two and damages the paint on the rear lid (figure 2).

Figure 2. Paint damage due to contact between the rear lid tail lamp and rear lid.

Any damage to the painted surface and/or corrosion protective surface on the rear lid will need to be repaired. Arrange this repair through your Audi Certified Collision Center. Before releasing the vehicle for the paint repair the buffers on the tail lamp will need to be modified to prevent subsequent paint damage.

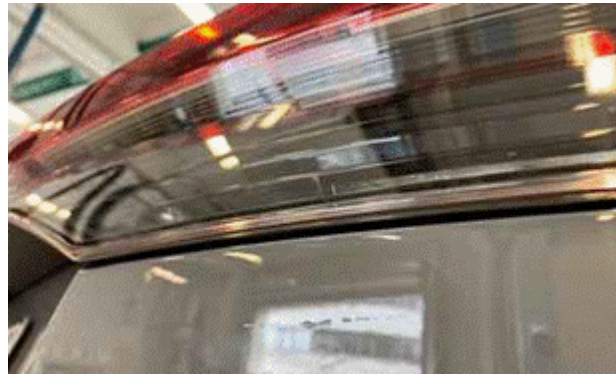
The gap between the rear tail lamp and rear lid has been optimized in production to eliminate contact between the two (figure 3).

Figure 3. Correct gap between the rear lid tail lamp and rear lid.

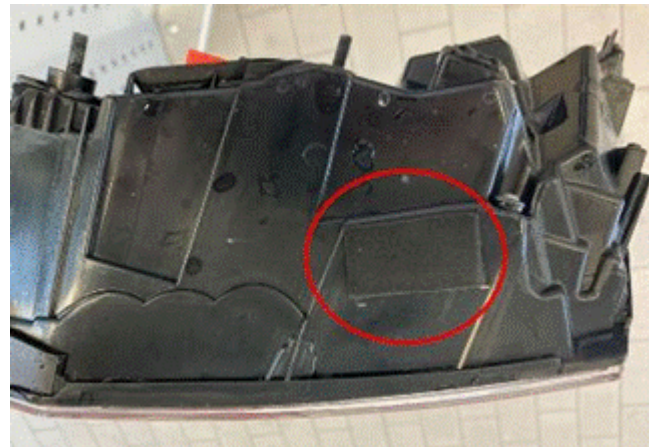
Figure 4. Buffer on tail lamp to be removed.

1. Remove the tail lamp on the rear lid. The foam buffers shown in figure 4 need to be carefully removed. They will be repurposed.

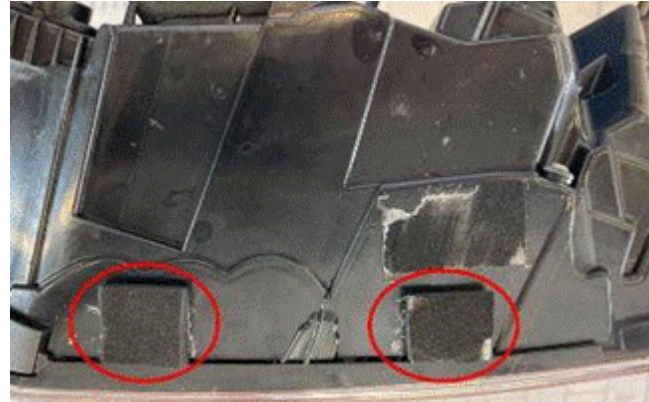
Figure 5. Foam buffer pieces reaffixed to the tail lamp housing.

2. Cut the original foam buffer into two equal pieces and secure them to the positions on the tail lamp shown in figure 5. Use a thin film double-sided tape for reaffixing the foam buffer pieces to the tail lamp housing (e.g. 3M™ 9088).

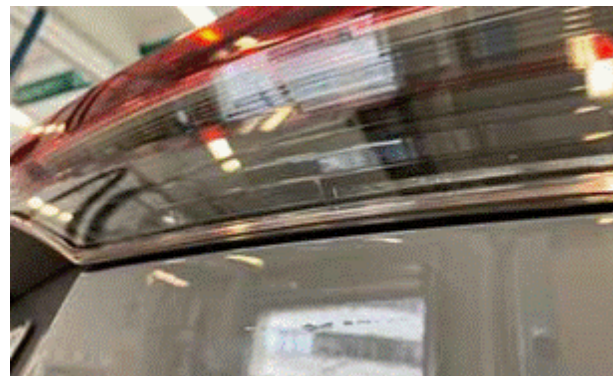
Figure 6. Correct gap between the rear lid tail lamp and rear lid.

3. After installing the foam buffer pieces reinstall the tail lamp and ensure that the appropriate gap is now established and no contact between the tail lamp and the rear lid exists on either side (figure 6).
