SIB 51 21 22

## WINDSHIELD LATERAL SEAL GAP

E-Series	Model Description
G70	7 Series Sedan

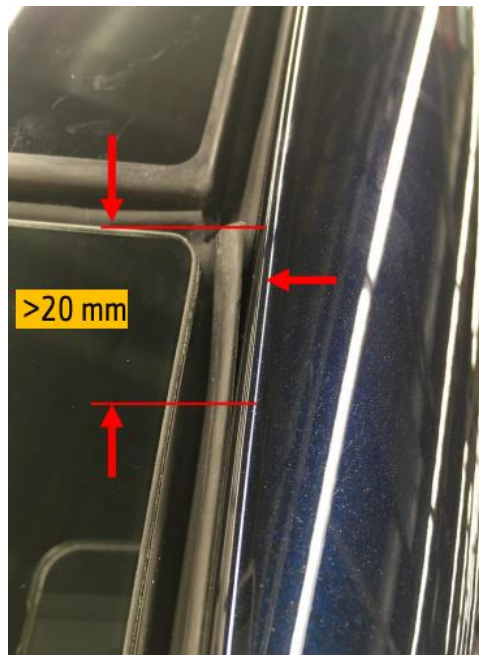
Gap between the windshield lateral seal and the A-pillar(s).

The strength of the adhesive seal is insufficient.

Apply double sided adhesive tape as shown in the photo below.
