SIB 52 09 20

HEAD RESTRAINT AND/OR BACKREST OF 3RD ROW SEATS CANNOT BE FOLDED DOWN

E-Series	Model Description
G07	X7 Sports Activity Vehicle

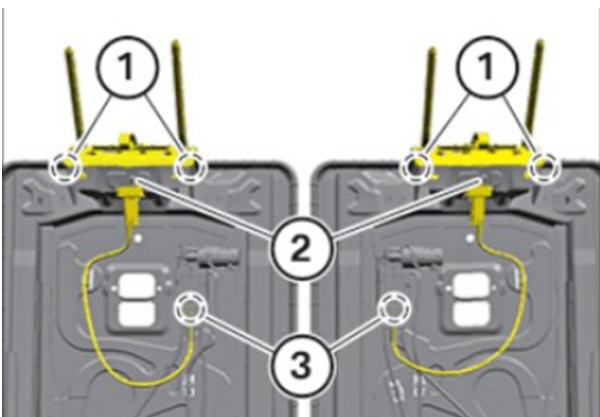
Can the head restraint be manually unlocked using the release loop beneath the headrest (see picture) and thus folded down?

YES = Head restraint mechanism is faulty. Determine root cause of Bowden cable not moving (see steps below). If the cable is moving fully but the headrest is not folding, then replace the folding module of the head restraint (#2 in picture).

See REP 52 30 118 Remove and install/replace folding module of left or right head restraint

NOTE: The head restraint cannot be removed without destroying the covering material. **A new cover (leather) will be required to perform this repair.**

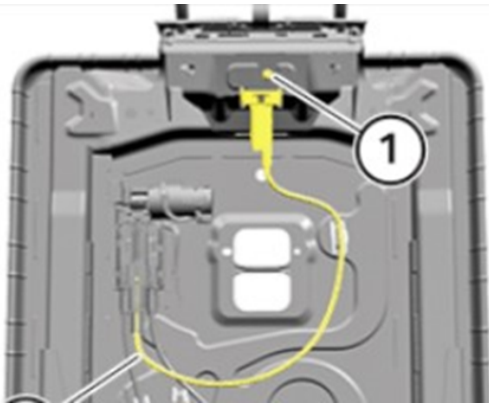
NO = Check if the Bowden cable is correctly mounted and properly routed.

If the Bowden cable is mounted properly and cable correctly routed and the electric motor moving the common housing pulls all 3 Bowden cables equally but the headrest Bowden cable does not travel far enough, replace the Bowden cable for the headrest (shown in yellow in picture).

See REP 52 30 253 Replace Bowden cable for left or right head restraint (Bowden cable unlocking device for head restraint).

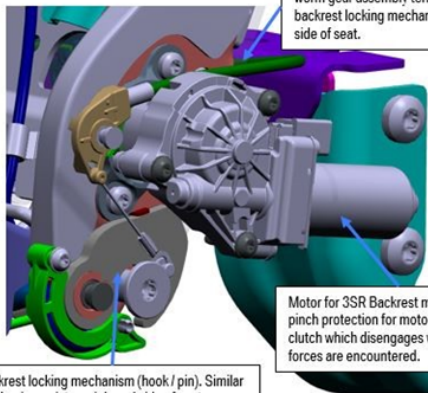
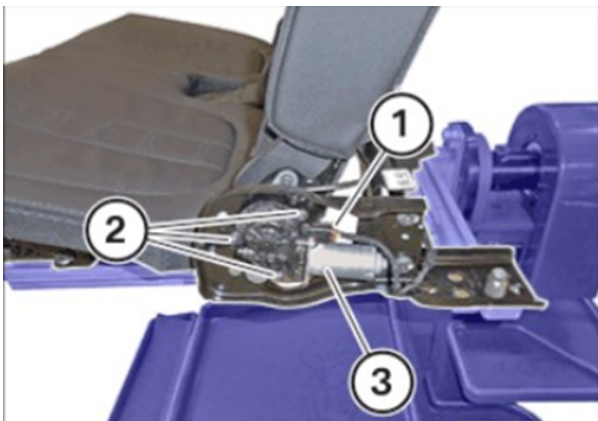
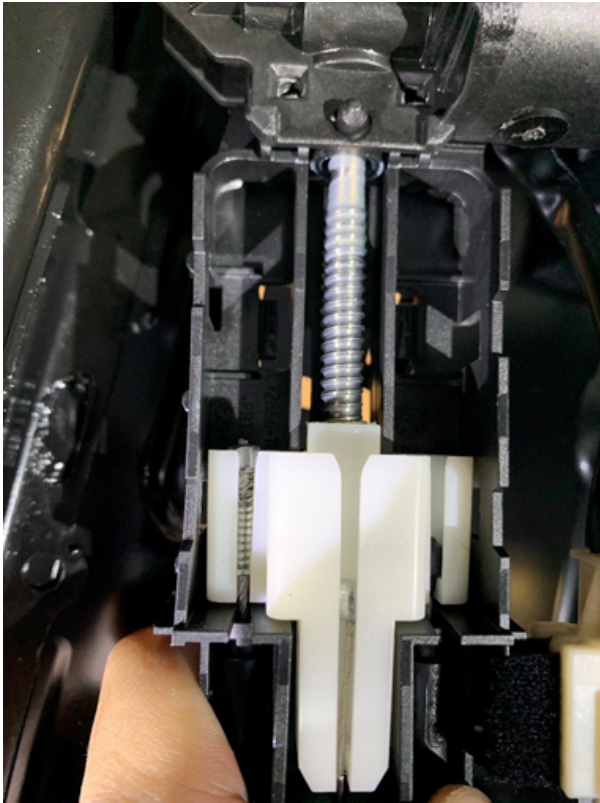
G07 3rd Row Seat – Overview Picture.

Bowden cable which originates at motor / worm gear assembly terminating at backrest locking mechanism on outboard side of seat.

Motor for 3SR Backrest movement. No pinch protection for motor, but has clutch which disengages when high forces are encountered.

Backrest locking mechanism (hook / pin). Similar mechanism exists on inboard side of seat.

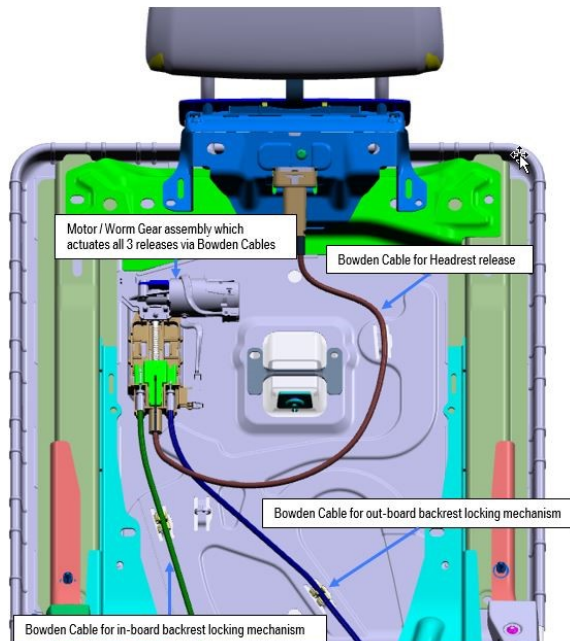
Is the drivetrain for the backrest release (actuator) broken?

YES = Replace only the drivetrain for backrest release (actuator).

See REP 67 31 645 Remove and install/replace drivetrain for backrest release of third-row seating (left or right) (according to vehicle diagnosis)

NO = Replace BOTH the Bowden cable(s) and drivetrain for backrest release (actuator).

See appropriate repair instruction:
 REP 52 30 256 Replace Bowden cable for left or right rear seat backrest (Bowden cable for outer backrest release)

REP 52 30 255 Replace Bowden cable for left or right rear seat backrest (Bowden cable for inner backrest release)

REP 67 31 645 Remove and install/replace drivetrain for backrest release of third-row seating (left or right) (according to vehicle diagnosis)
