MIL ON With DTC P019064

Service Category Engine/Hybrid System

Section Engine Control

YEAR(S)	MODEL(S)	ADDITIONAL INFORMATION
2019	Avalon HV	
2018 - 2019	Camry HV	
2019 - 2021	RAV4 HV

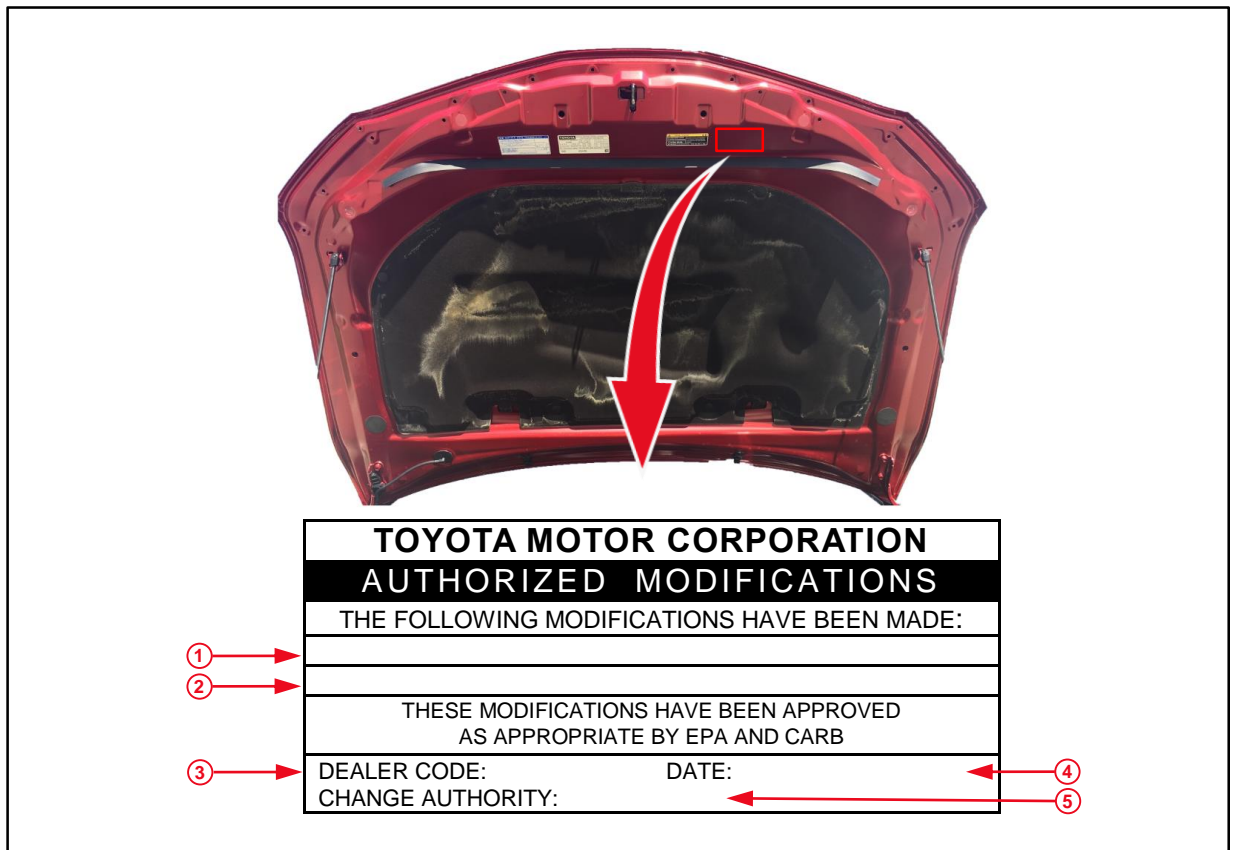
Figure 1. Location of Authorized Modifications Label on 2019 Avalon HV

1	Replacement ECM (PCM) Part Number (e.g., 89661-07651)
2	New Calibration ID (e.g., 896630724100)
3	Dealer Code

4	Date Completed
5	This SB Number

- Use Techstream to confirm if the ECM (PCM) calibration has been updated and check for the Authorized Modifications Label affixed to the vehicle in the locations shown in Figures 1 – 3.

- Prepare and install the Authorized Modifications Label.
 - Using a permanent marker, enter the following information on the label:
 - ECM (PCM) part number [Refer to the **Parts Information** section for the **NEW PART NUMBER**]
 - Calibration ID(s) [Refer to the **Calibration Information** section for the **NEW CALIBRATION ID**]
 - Dealer Code
 - Repair Date
 - Change Authority [This bulletin number]
 - Install the Authorized Modifications Label onto the vehicle at the locations shown in Figures 1 – 3. The Authorized Modifications Label is available through the MDC, P/N 00451-00001-LBL.

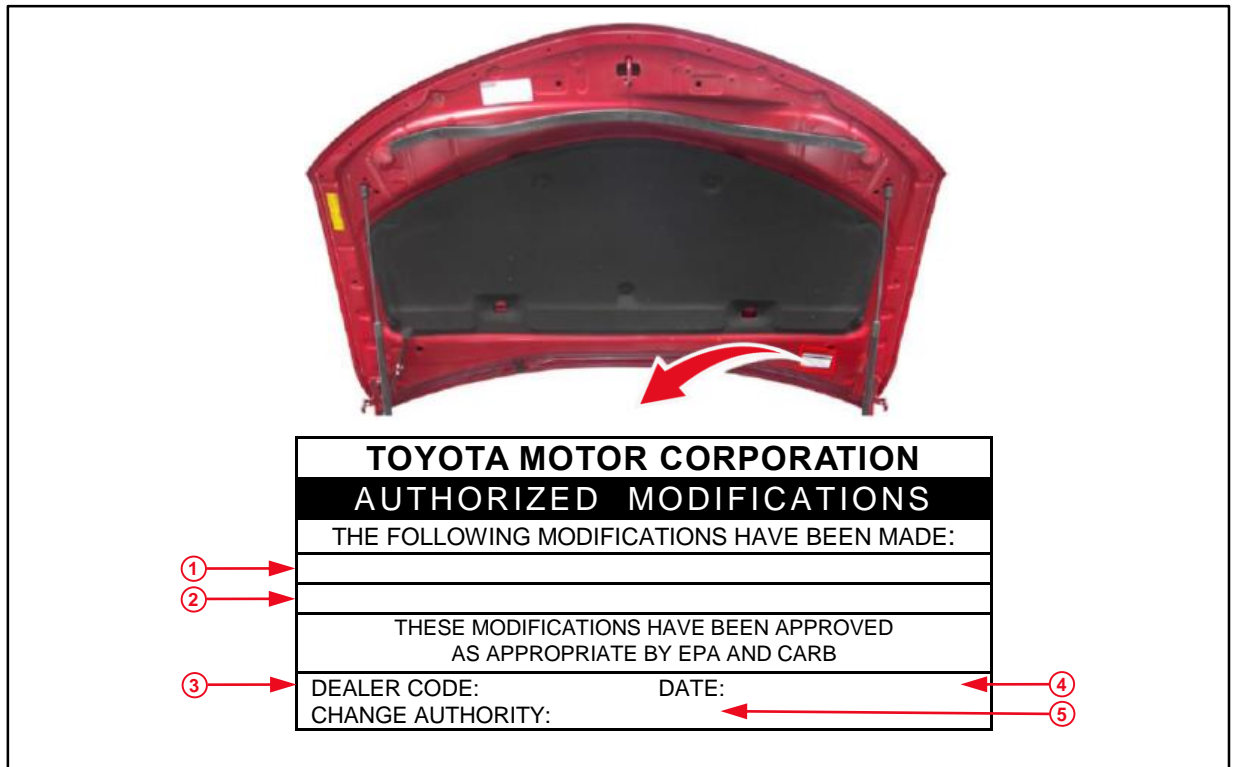
Figure 2. Location of Authorized Modifications Label on 2018 – 2019 Camry HV

1	Replacement ECM (PCM) Part Number (e.g., 89661-0X561)
2	New Calibration ID (e.g., 8966306R6100)
3	Dealer Code

4	Date Completed
5	This SB Number

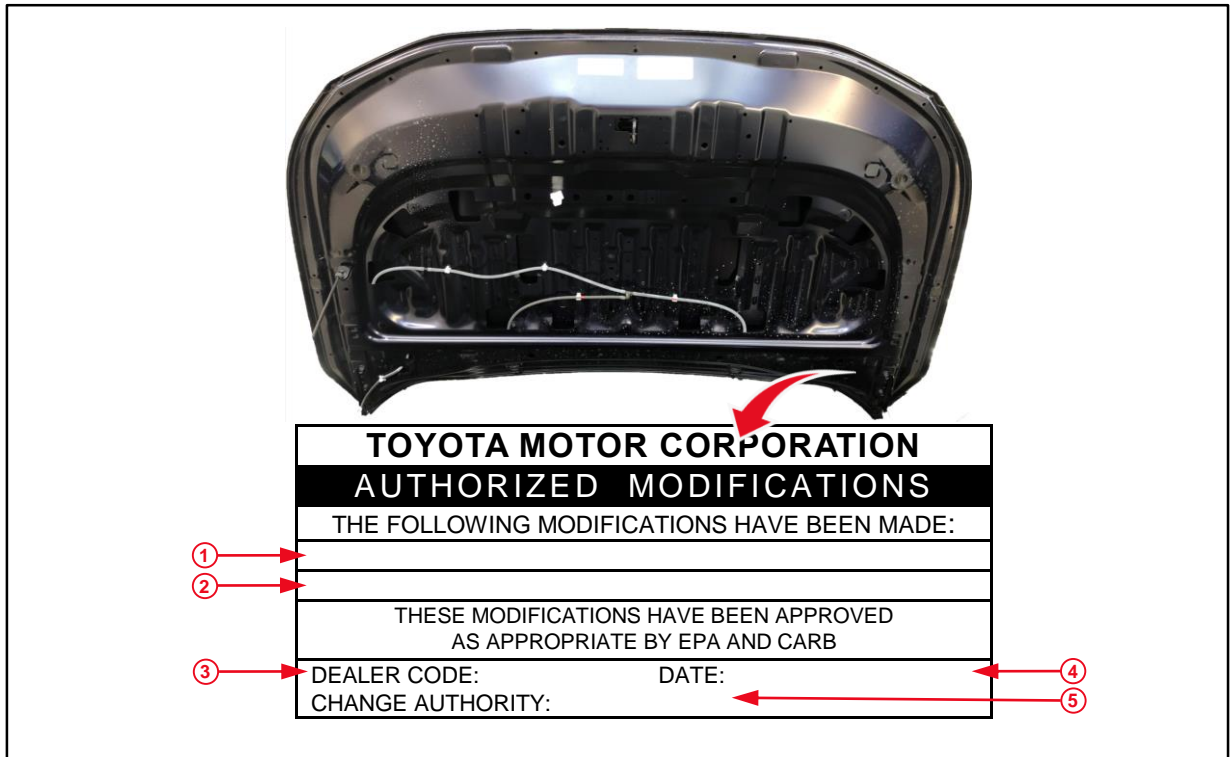
Figure 3. Location of Authorized Modifications Label on 2019 – 2021 RAV4 HV

1	Replacement ECM (PCM) Part Number (e.g., 89661-4AA31)
2	New Calibration ID (e.g., 896634A13100)
3	Dealer Code

4	Date Completed
5	This SB Number
